**Bainbridge Island Metropolitan Park & Recreation District
Regular Board Meeting 6:00 pm
Thursday – February 16, 2023**

**RAY WILLIAMSON POOL
COMPREHENSIVE CONDITION REPORT
BAINBRIDGE ISLAND METRO PARK & RECREATION DISTRICT
PROJECT NO.: 2208 FINAL DRAFT**

Stemper Architecture Collaborative and the consultant team (Stemper AC Team) performed a comprehensive condition assessment (CCA) of the Ray Williamson Pool (RWP) at Bainbridge Island Aquatic Center (BIAC) for Bainbridge Island Metropolitan Park and Recreation District (BI Parks). The site visit took place on September 14, 2022 in which the Stemper AC Team reviewed all building systems and components at the exterior and interior including but not limited to: building envelope systems such as roof and wall assemblies, window systems, major and minor structural systems, mechanical, electrical, and plumbing/drainage systems. Building usage, wear and tear, and areas of concern/interest were also reviewed along with concrete pool deck and paving, pool equipment/auxiliary use items, pool gutter and liner system, general review for moisture intrusion, and review for accessibility compliance (ADA). Additionally, the Stemper AC Team ens

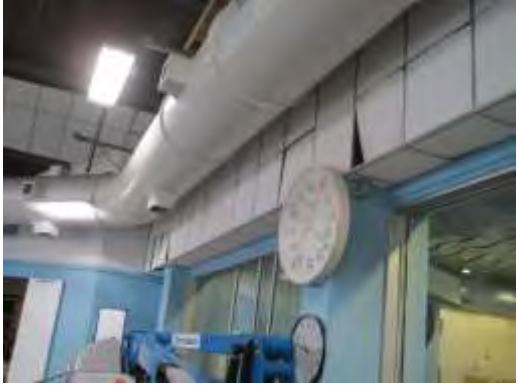
2. Natatorium – aged and worn paint

Deficiency: paint peeling, damaged and wall discoloration is evident in various locations throughout the natatorium and auxiliary spaces.

Recommendation: patch, prepare and repaint walls with epoxy coating.

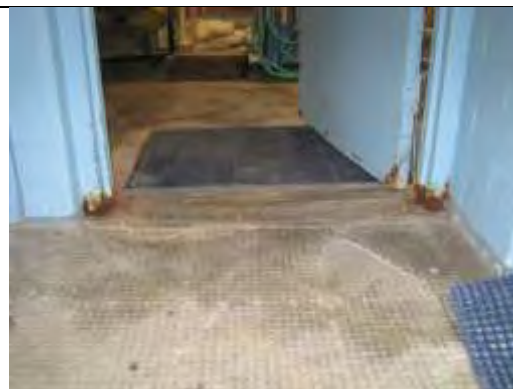
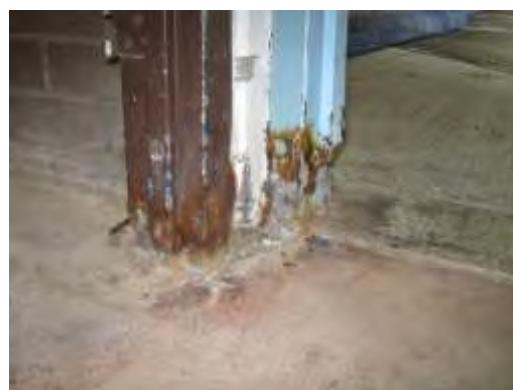
17. Southwest ramp

Deficiency: some existing vertical posts at handrails are corroded and handrail is showing age from long term use, constant use of the pool over time has caused the concrete surfacing to erode at the ramp landing and pitting and exposed aggregate are visible. Handrail paint is peeling. Handrail also needs to be detached from the storefront system.

Recommendation: replace handrail and post system with corrosion resistant one (eg: stainless steel) and redesign to be a stand alone handrail. Consider filling and levelling the pitted areas and place a skid-resistant urethane or PMMA type coating system over the ramp and landing.

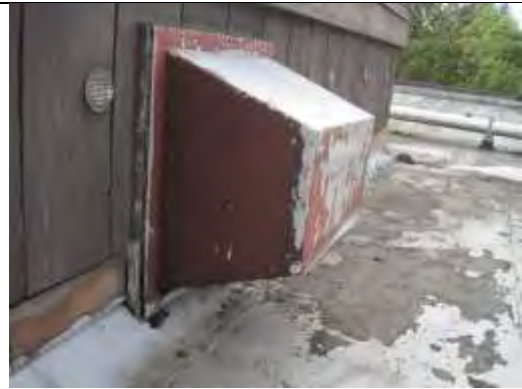
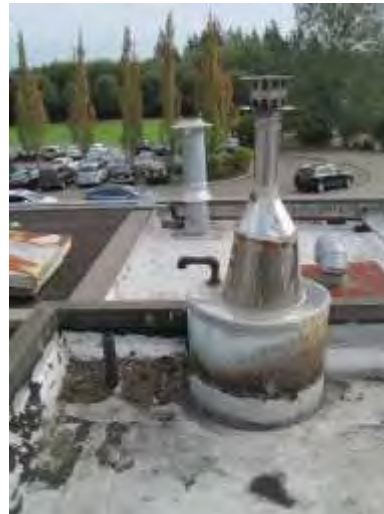
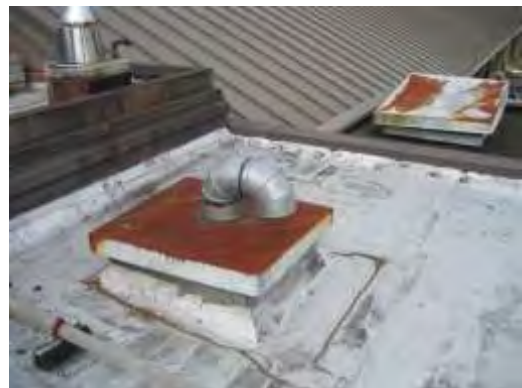
32. Roof drains, scuppers – low slope roof

Deficiency: existing roof drains are aged and corroded.

Recommendation: replace roof drains and scuppers; verify condition of leaders for blockage, flow, and damage. Coordination with mechanical engineer required.
