TECHNICAL MEMORANDUM

Date October 20, 2023
To Lydia Roush
Bainbridge Island Metro Parks and Recreation
From John Bornsworth
Principal and Ecologist with Peninsula Environmental
ISA Board Certified Master Arborist® #PN-7955BM
Registered Consulting Arborist #724
Subject Tree Risk Assessment
Sites Madison Tot Lot

1 Summary

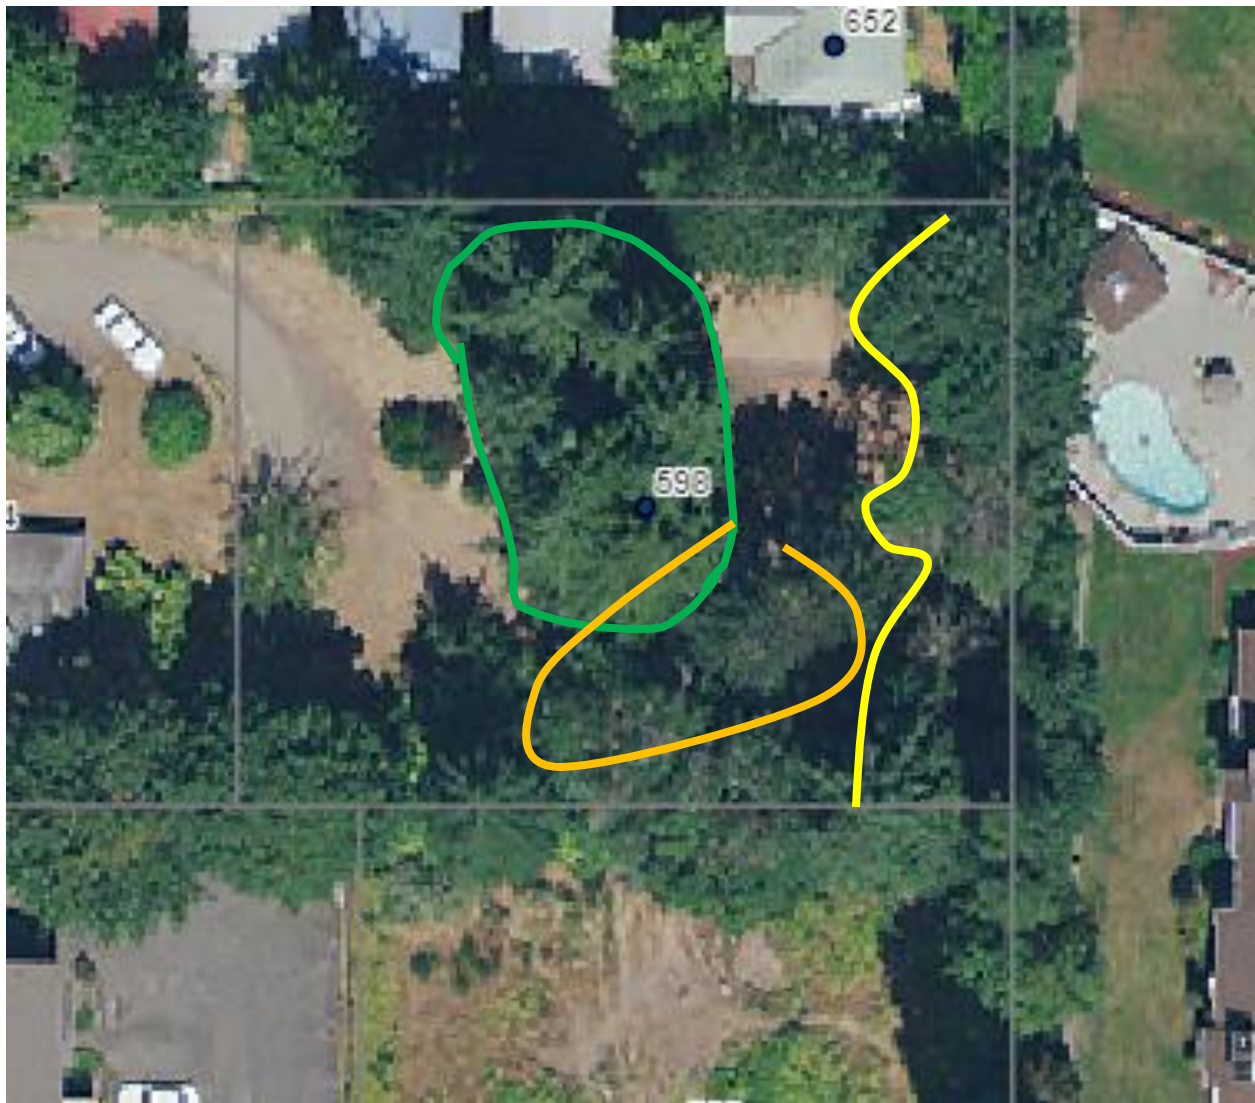
Figure 1: Snip of aerial imagery from Bainbridge Island GIS Portal, dated 2018. Accessed 10/20/23.

1. Green circle is generally over low risk, healthy Douglas-fir remnant forest stand.
2. East of yellow line is generally the stand of declining big leaf maple.
3. Orange ellipse is general canopy of pacific madrone with canopy dieback.

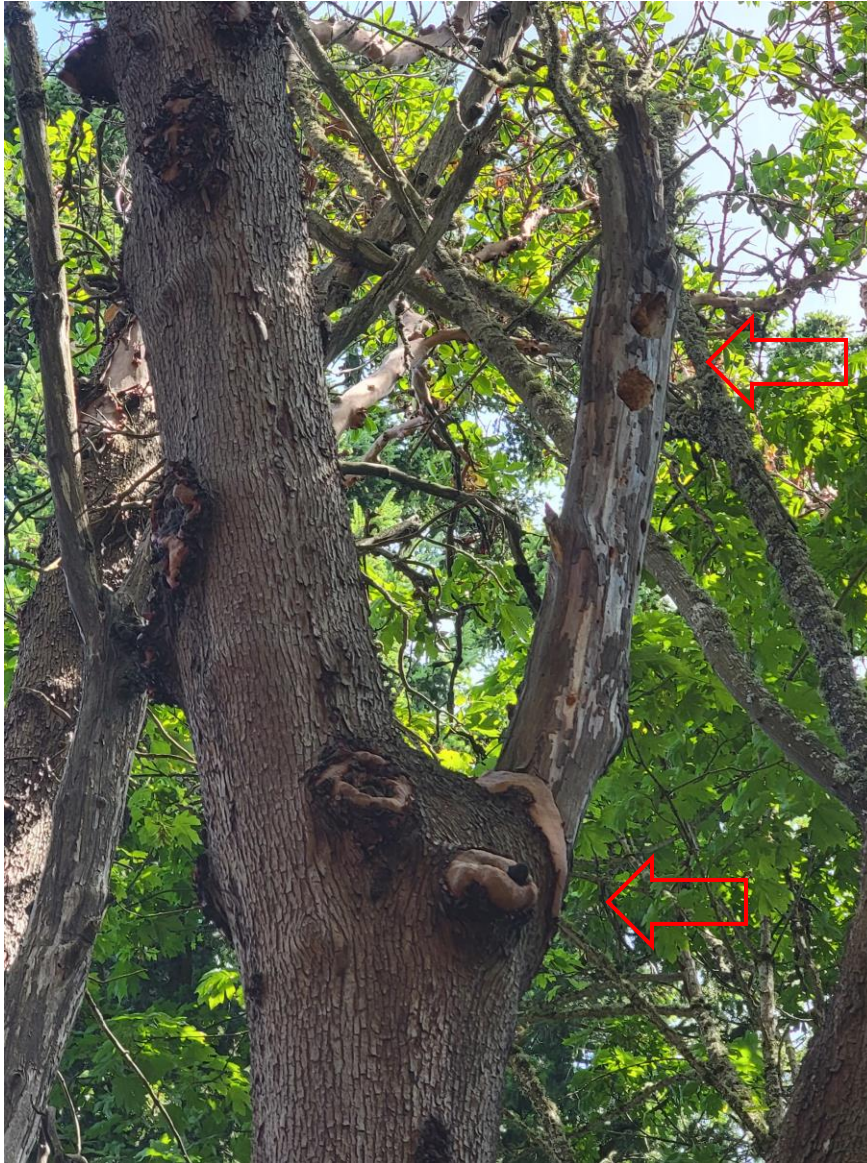
Figure 3: Pacific madrone mid-canopy.

Tree shows significant die back, roughly 35%-40% of the canopy. Three to four large dead branches with no visible foliage are growing generally apical and upwards.

Significant colonization of madrone canker (*Neofusicoccum arbuti*) along main stems and trunks. *N. arbuti* is expressed with sunken, black cankers with callused margins, with margins often appearing greenish due to the consistent new wood growth. *N. arbuti* can be pruned away, but not in this scenario as the cankers are too widespread.

Note dead stem and nesting cavities created in decayed wood.

Note protruding growths of *Neofusicoccum arbuti*.

N. arbuti is not a wood decay pathogen, meaning the wood of the host tree is not compromised by the fungi, but it will result in death of the host tree. Pacific madrone wood is not prone to failure, as can be observed with this specimen showing significant dieback with almost no limb failure. Nonetheless, the dead wood on this tree should be pruned away.

- a. Entire tree is qualified as low risk of significant trunk failure in three years.
- b. The declining canopy of tree is moderate to high risk of failure in three years.
- c. Targets include the park's sitting areas, thoroughfare, and potentially the activity playground.
- d. Recommendations to reduce associated risk –
 - i. **Objective:** Remove smaller, longer dead wood that has a tendency of failure. Retain larger, shorter dead wood that is attached enough to be stable from typical wind and snow loads. Retain safe habitat features in tree, including birds nests on large stems that are unlikely to fail in typical weather.
 - ii. Remove all dead branches from tree that are less than 6 inches in diameter.
 - iii. In this process, leave no dead wood branch greater than 6 feet long, irrelevant of diameter.

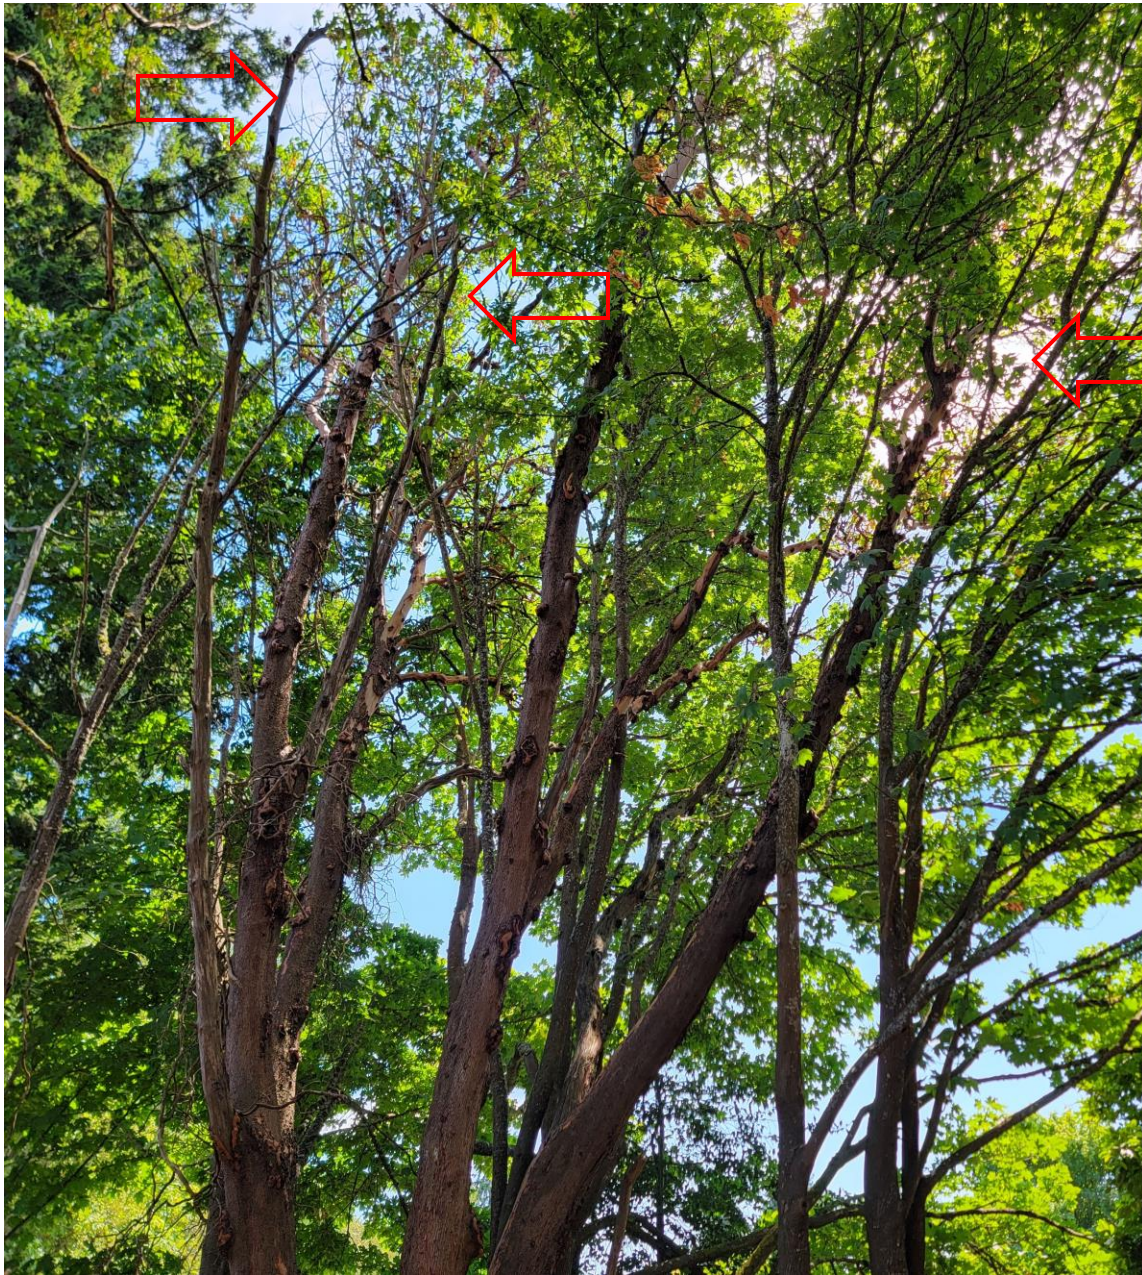
Figure 4: Pacific madrone full canopy.

Note the upper canopy dieback of approximately 40% of the pacific madrone.

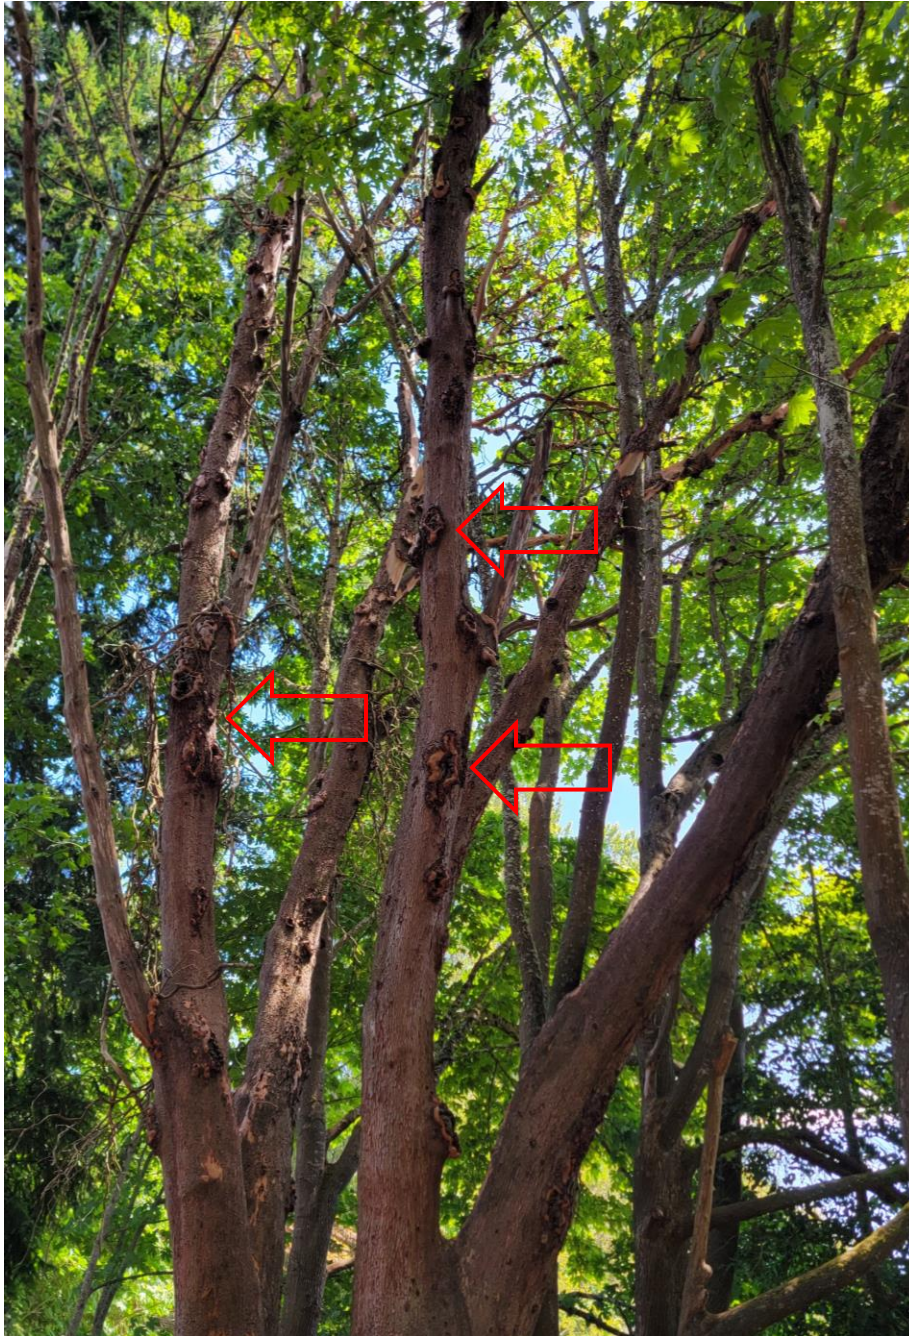
Figure 5: Pacific madrone cankers

Note more madrone canker presence along stems of tree.

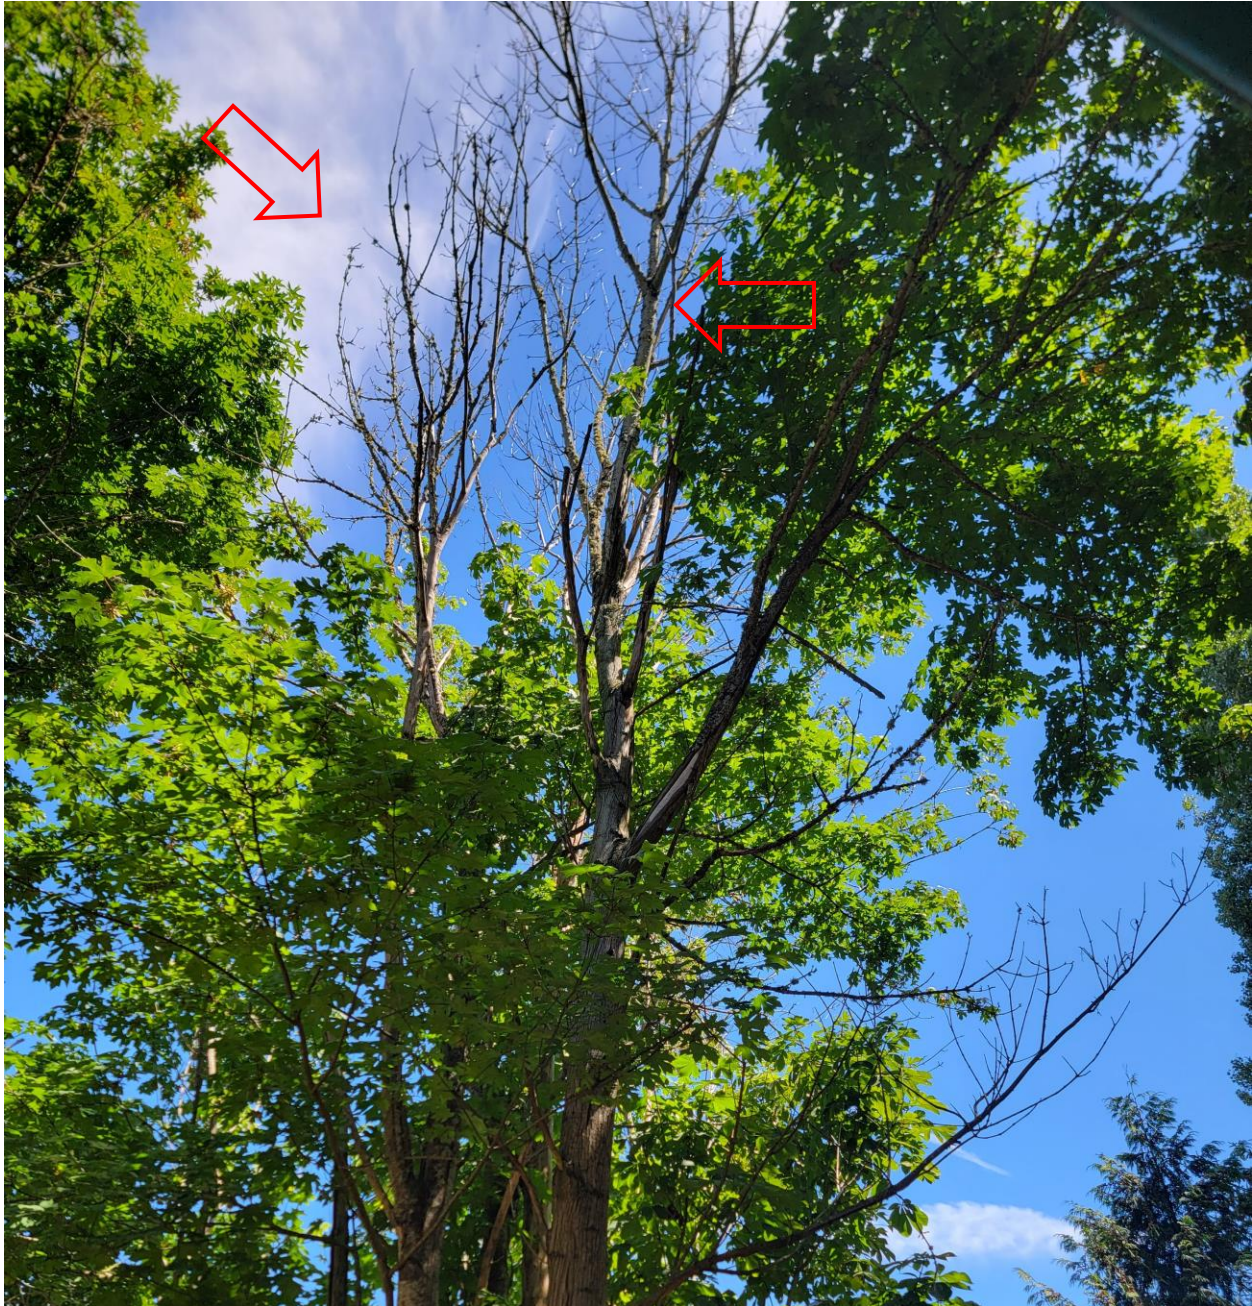
Figure 6: Tree 2/3 big leaf maple deadwood in canopies

2. **Tree 2/3 (Big leaf maples with branches near and over the activity park):** Two big leaf maple trees are growing on the southwestern corner of the property, and are approximately 23-26 inches in diameter. Trees have significant dieback on the upper canopy, likely due to signs of mechanical damage on the lower trunk. No fungal or pest symptoms or signs were observed.

The other maple trees in the same general location show similar mechanical damage on their trunks. The mechanical damage and sloughing bark has signs of callusing wound wood, a sign that the damage was done 5-10 years ago. The location of damage and timeline corresponds to the nearby construction at the apartment complex and creation of the park.

- a. Entire tree is qualified as low risk of significant trunk failure in three years.
- b. The declining canopy of tree is high risk of failure in three years.
- c. Targets include the activity playground and park sitting areas.
- d. Recommendations to reduce associated risk with dead wood –
 - i. **Objective:** Remove entire upper canopy that is died back. The size of existing deadwood is too small to be commonly associated with habitat.
 - ii. Remove all dead branches from trees, irrelevant of diameter.
- e. Recommendations to reduce associated risk with elongated branch –
 - i. Remove entire branch at branch collar connection to trunk.

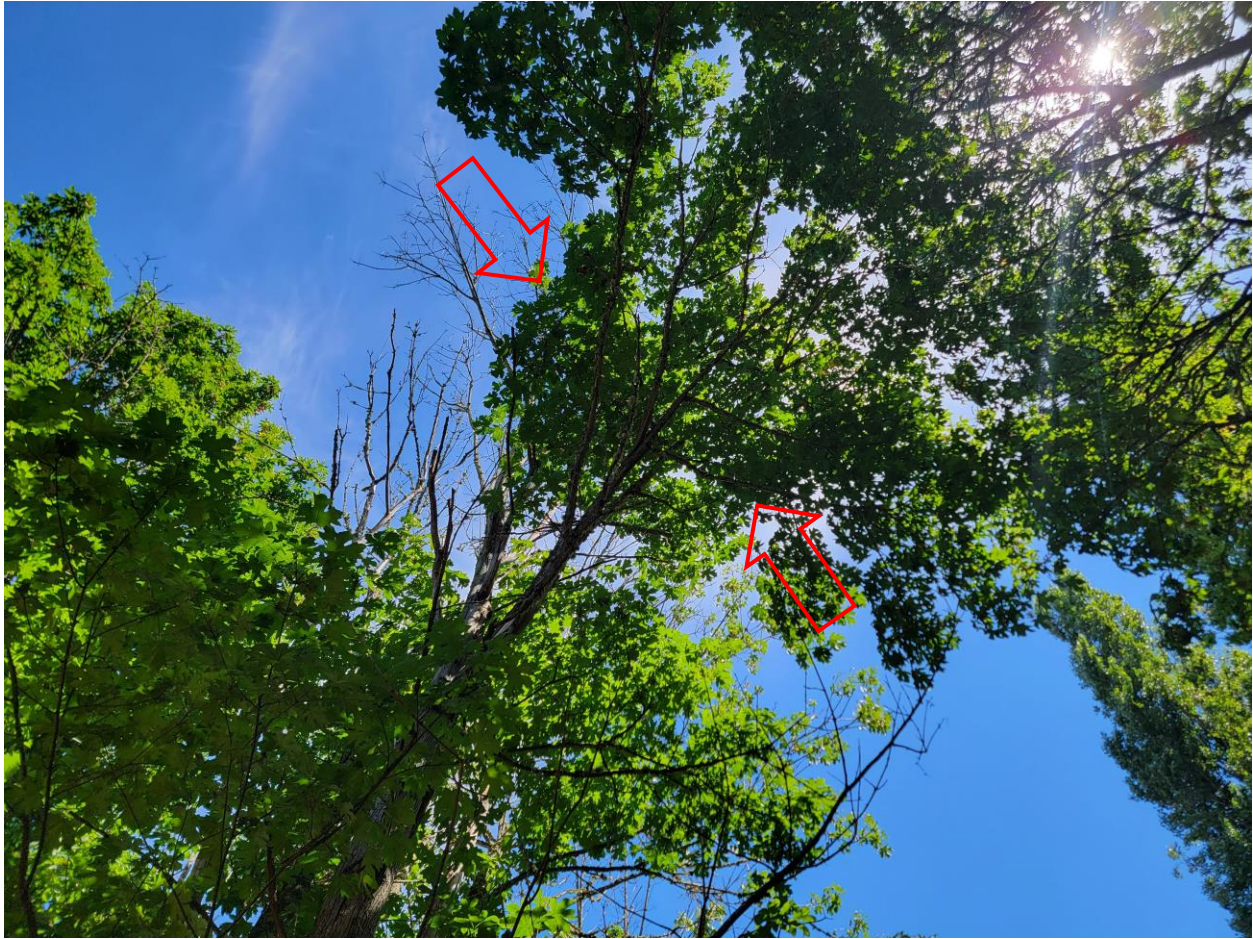
Figure 7: Tree 2/3 big leaf maple extended branch.

Further, there is a large, elongated branch growing above the activity playground. This elongated branch is fully foliated, yet its growth habitat is indicative of future failure. This branch should be fully removed.

Note activity playground is directly beneath.

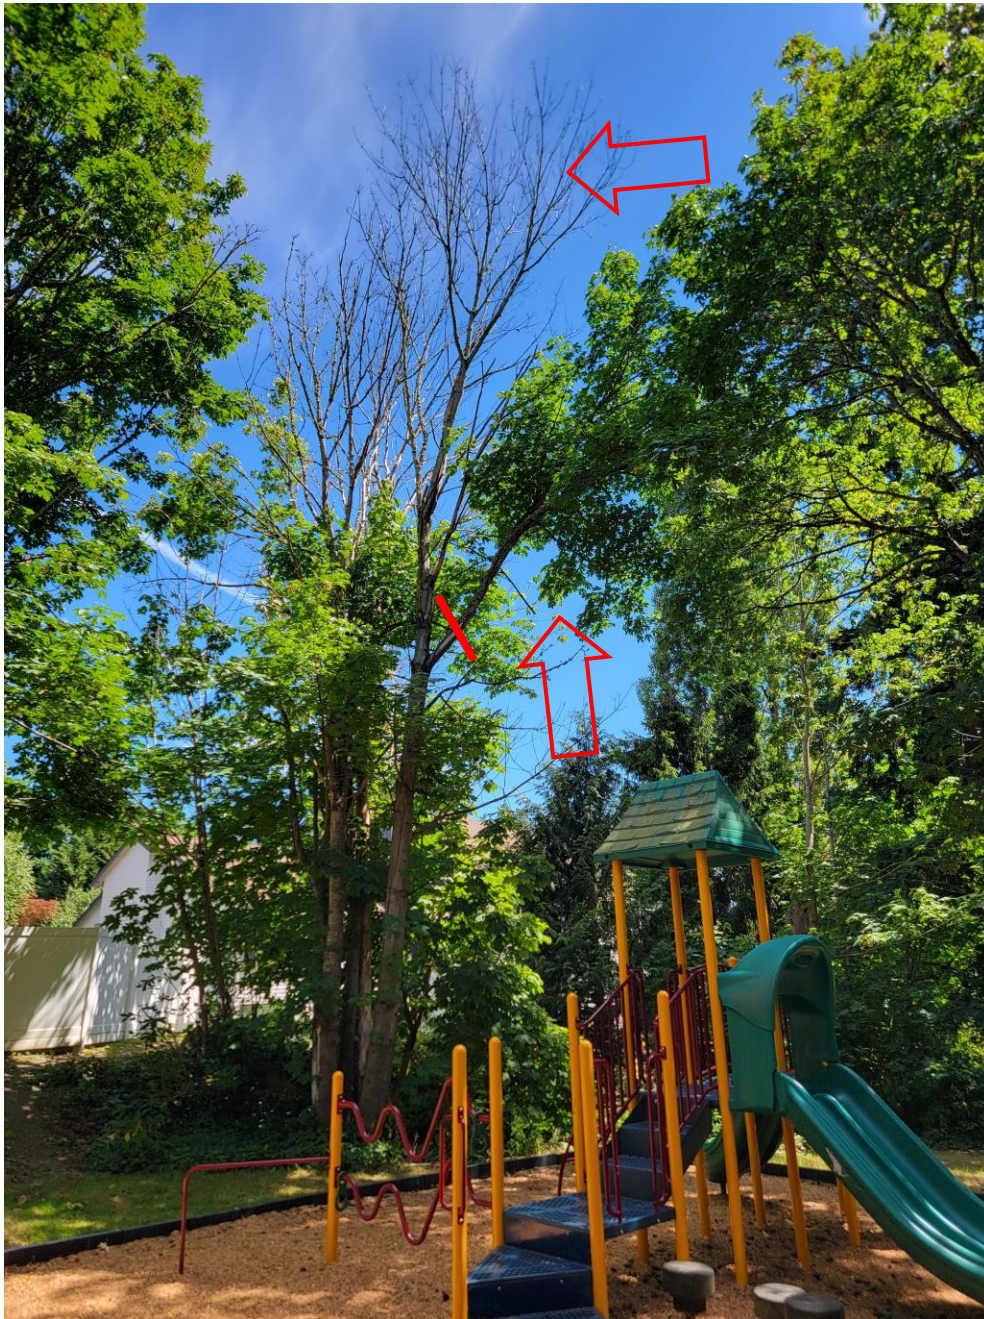
Figure 8: Tree 2/3 big leaf maples

Red line indicates overhanging branch to remove.
