**NEEDS ASSESSMENT:
RAY WILLIAMSON POOL**
Bainbridge Island, Washington

10 August 2017

Bainbridge Island
Metro Park & Recreation District

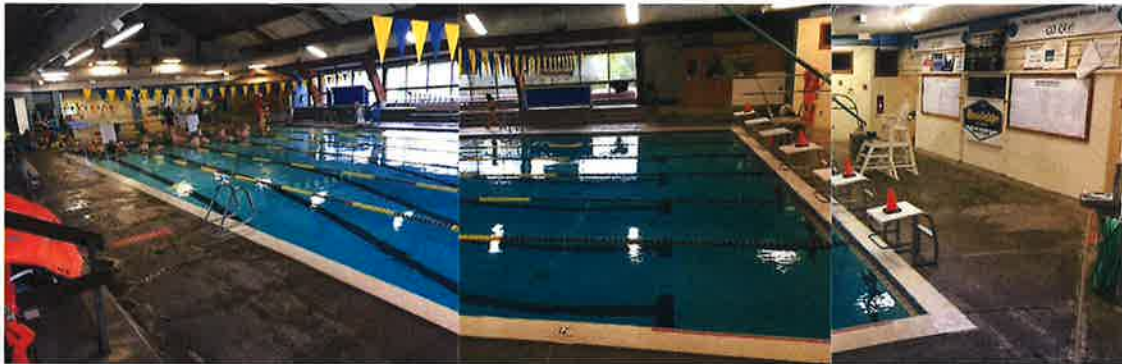
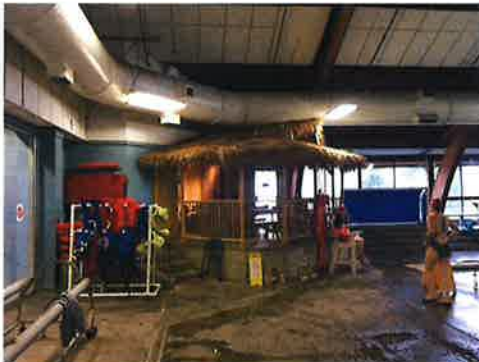
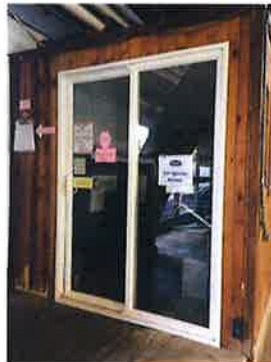
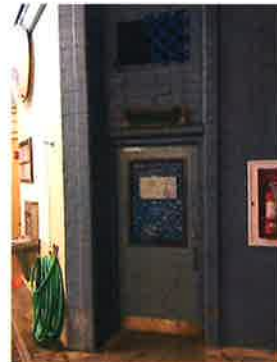
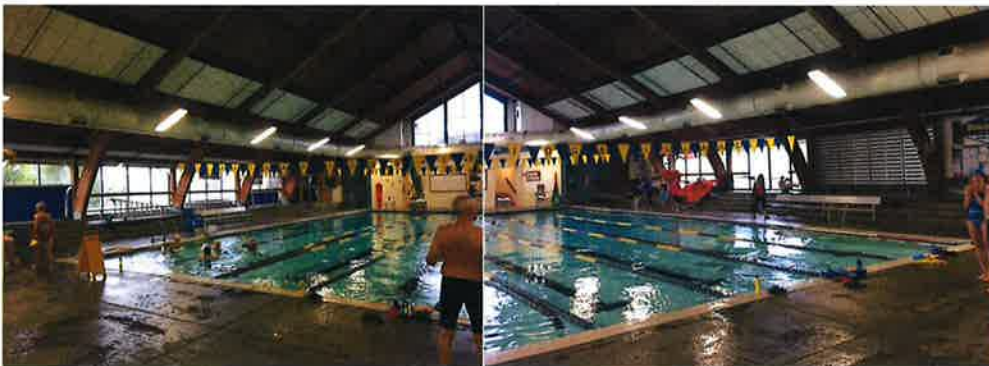
Exhibit 5: Ray Williamson Pool

The swimming pool is rectilinear, 75 feet (25-yards) in length and approximately 42 feet in width. It has six 7'-0" wide swim lanes across the 42 feet width of the pool. The pool features four sets of grab rails with steps that extrude into the pool walls below them into the outside two lanes. Pool depths range from 3'-0" in the north end of the 25-yard lap lanes down to a 13'-0" depth at the south end.

The pool features six racing platforms / starting blocks at the south end and one 1-meter springboard.

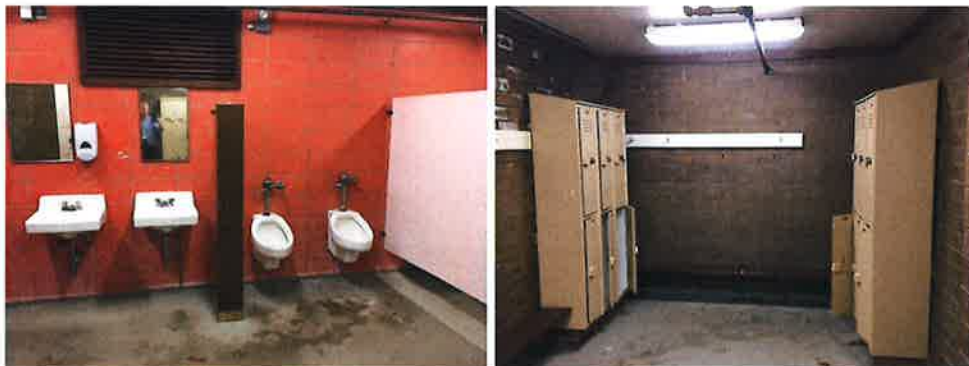
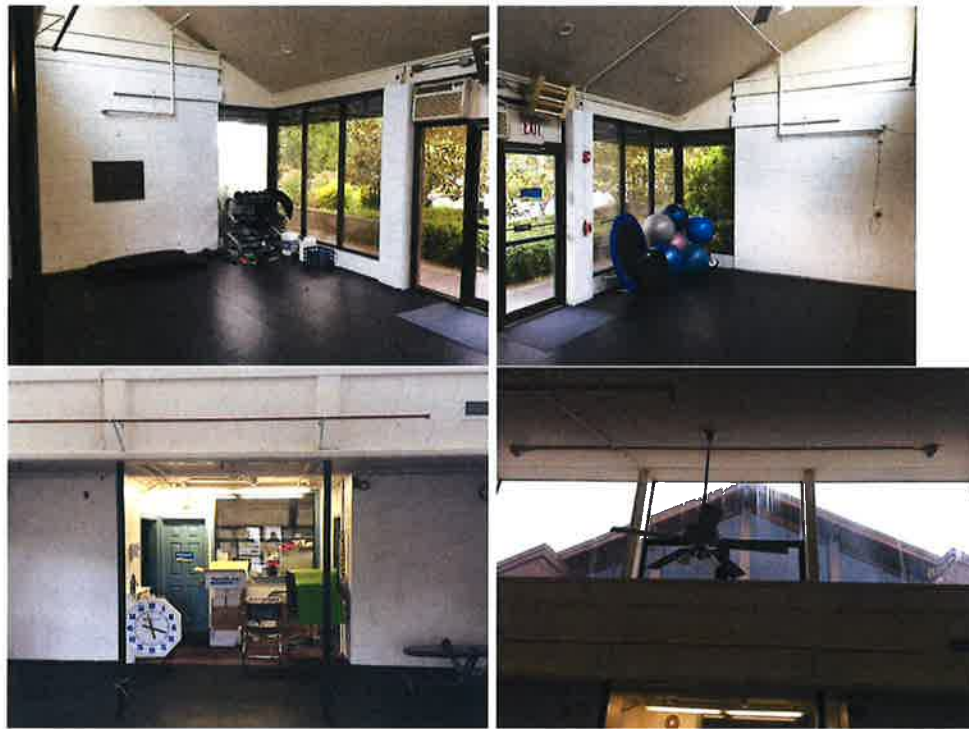
Exhibit 8: Original Ray Williamson Locker Rooms, Offices, & Multi-Purpose Room

The old lobby area, as previously mentioned, has been renovated and is now used as a multi-purpose fitness space. This area has a space heater and an air-conditioning unit as well as a fan for the comfort of users. There are also three offices in this space one for the BISC Head Coach, the Pool Operator, and the BAM Head Coach.

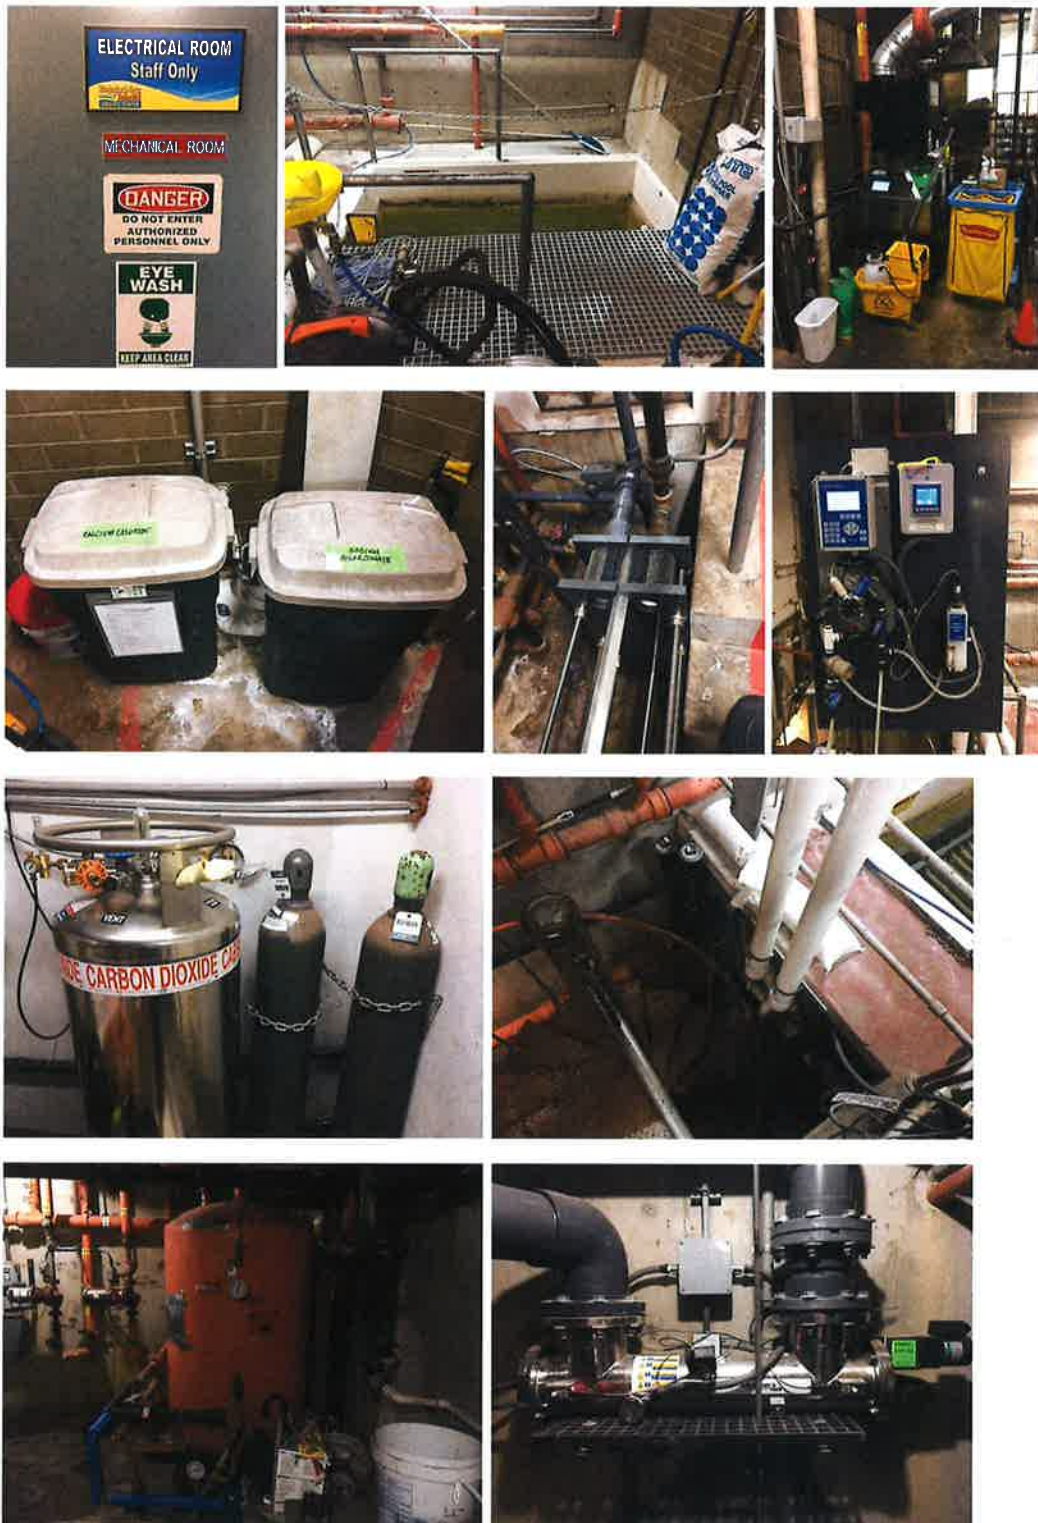
Exhibit 9: Ray Williamson Pool Mechanical Room & Pool Equipment / Systems

The mechanical and chemical systems for the Ray Williamson Pool are located to the southeast of the building. The room also includes the electrical equipment for the building. The pool specific equipment is located on two levels. The top level includes the opening of the DE filter pit, some dry chemical storage (Calcium Chlorine, Sodium Bicarbonate), hot water heater with plate and frame heat exchanger, floor scrubber, chemical controller and variable speed drive control panel, CO₂ cylinders and feed system, muriatic acid drums and feed system, soda ash drums and feed system, emergency eyewash station, and the staircase to the basement level below. There is a separate gas chlorine room that can only be accessed through the outside as well.

The basement level is accessed through a ships ladder and houses the remaining equipment including a hot water tank, circulation pump and control, solar pump disconnects, hair and lint strainers, heater circulation pump, UV unit, and the majority of the pool piping.

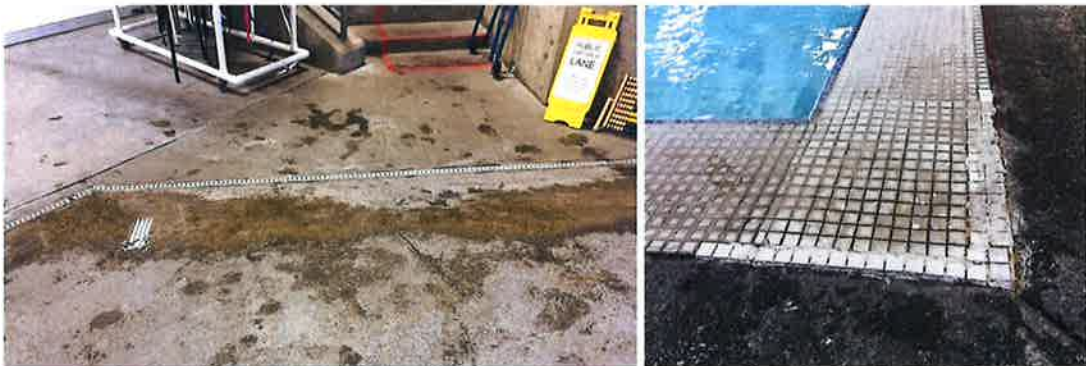
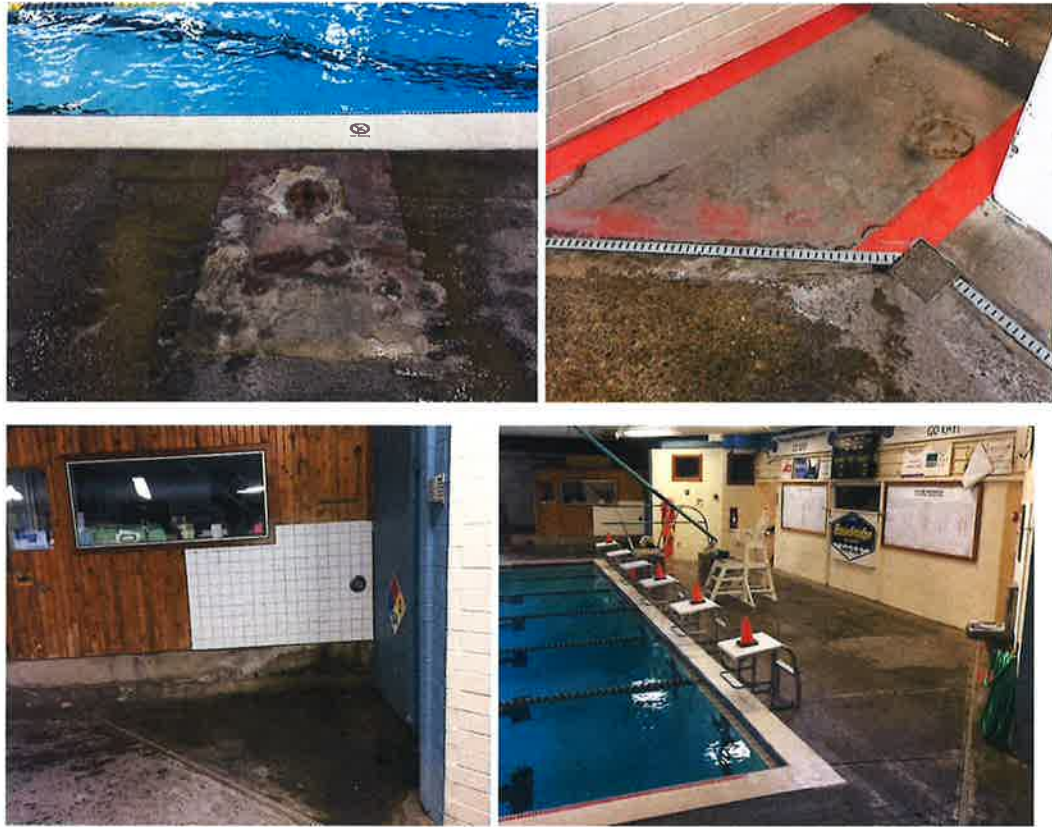
Exhibit 10: Ray Williamson Pool Deck

- 5.1 **Pool Deck:** The existing pool deck has worn over time and has sections where the finish has deteriorated to the point it is no longer uniform and non-abrasive. It does not appear to have sufficient slip coefficients in many areas. Pooling water can be seen in multiple areas and it is the opinion of Aquatic Design Group that the decks are unsafe as evidenced by some slips and falls.

The estimate below assumes the decks will be removed and replaced from the edge of concrete bleachers on the east and west, at the building walls / doorways on the south, and at the glass doors on the north side towards Nakata. The estimate also includes retiling the deck surface and replacing it with a similar contrasting band of tile.

Cost to remove and replace deck:
\$ 198,000.00

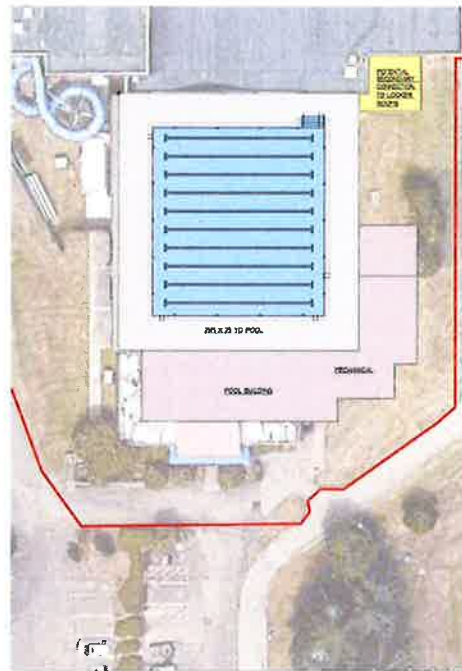
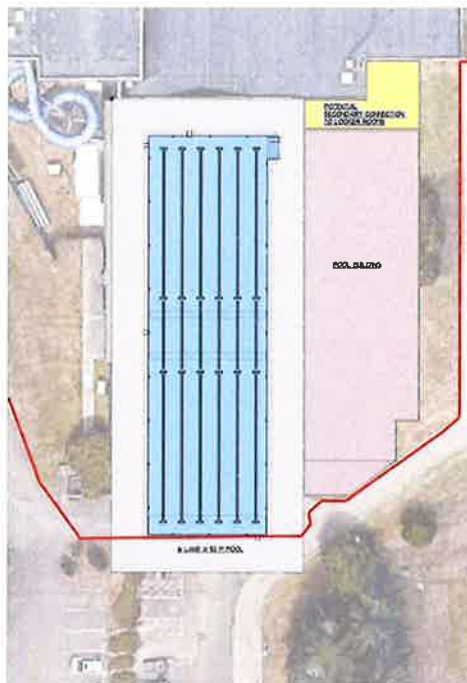
Exhibit 11- Current Layout and Options for Expansion (Black and Red Lines Denote Lease Line)

Aquatic Design Group has provided three options that show potential enhancement options. The first, Option 1, includes a new 25-yard x 25-meter pool on the existing site. The second, Option 2, includes a new 50-meter x 6-lane pool on the existing site. The third, Option 3, includes a new 50-meter x 25-yard pool, with no specific site. These options provide examples of what could be the right solution for Bainbridge Island. They are not meant to serve as official recommendations as to what should be done.

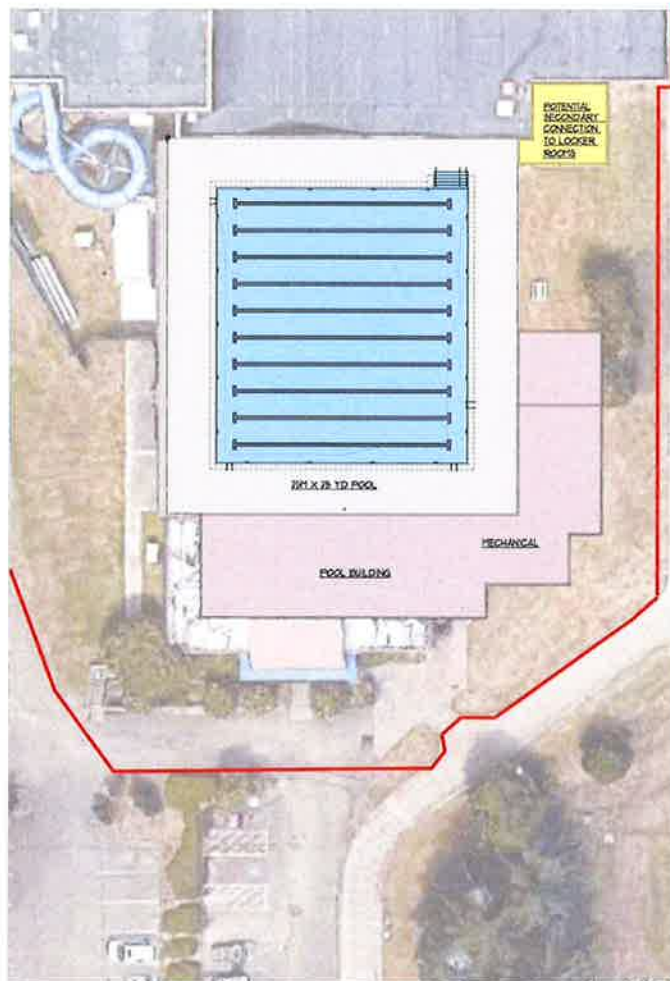
Exhibit 12- Option 1: New 25-yard x 25-meter pool

This option attempts to maximize pool space on the existing site with no need for extensive site work. The existing Ray Williamson Pool would be torn down and a new natatorium be constructed to be attached to the Nakata Pool and existing infrastructure. This option would include a 10-lane 25-yard lanes x eight 25-meter lanes. It would also include a minimal locker room on both the male and female side to support Ray Williamson specific programs, seating for 200 patrons, three new offices, new storage space, new mechanical equipment room (all on one level), a timing booth, a wet-dry classroom, and an officials area. An enlarged plan and area breakouts are below. The existing infrastructure (locker rooms, lobby, cash control, etc.) at the Nakata side of the Bainbridge Island Aquatic Center would support the Ray Williamson Pool during large events. The existing lobby would function as the primary entrance to the combined facility. In reviewing the spreadsheet it is important to remember this is a theoretical exercise and not a fully designed or vetted program.

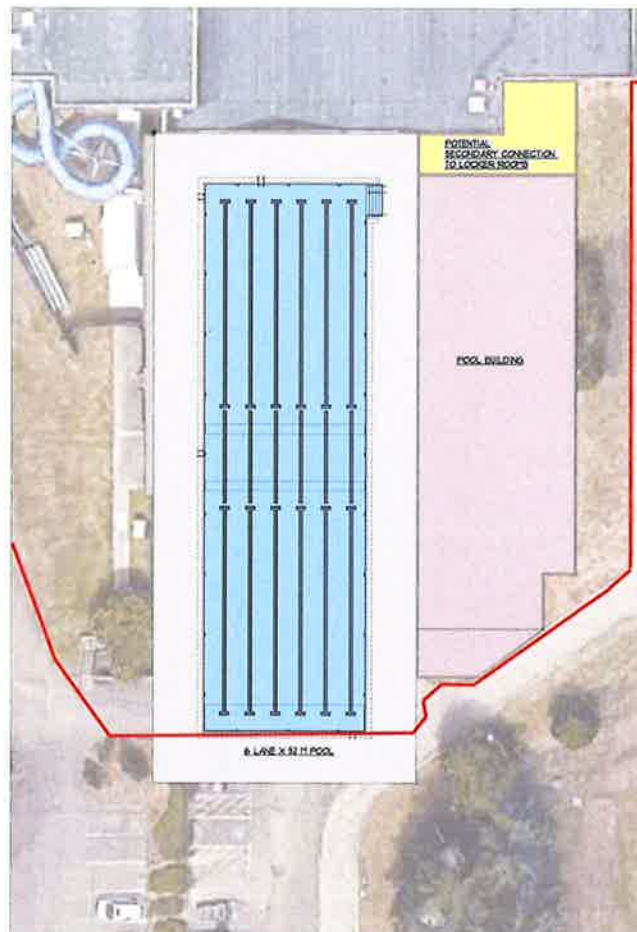
Exhibit 13- Option 2: New 50-meter x 6-lane pool

This option attempts to provide a 50-meter pool on the existing site. As can be seen by viewing the enlarged image below, there would be a need for site work including a retaining wall to the East and a re-routing of the fire lane to the South. The existing Ray Williamson Pool would be torn down and a new natatorium be constructed to attached to the Nakata Pool and existing infrastructure. This option would include six 50-meter lanes with two moveable bulkheads which would allow for up to twelve 25-yard lanes. It would also include a minimal locker room on both the male and female side to support Ray Williamson specific programs, seating for 400 patrons, three new offices, new storage space, new mechanical equipment room (all on one level), a timing booth, a wet-dry classroom, and an officials area. An enlarged plan and area breakouts are below. The existing infrastructure (locker rooms, lobby, cash control, etc.) at the Nakata side of the Bainbridge Island Aquatic Center would support the Ray Williamson Pool during large events. The existing lobby would function as the primary entrance to the combined facility. In reviewing the spreadsheet it is important to remember this is a theoretical exercise and not a fully designed or vetted program.
