# CRITICAL AREAS REPORT

**Grand Forest North**  
*Bainbridge Island, Washington*

Prepared for  
**Bainbridge Island Metropolitan  
Park & Recreation District**  
7666 NE High School Road  
Bainbridge Island, WA 98110  
(206) 842-2306

Prepared by  
**Ecological Land Services**  
1157 3rd Avenue, Suite 220A • Longview, WA 98632  
(360) 578-1371 • Project Number 2248.07

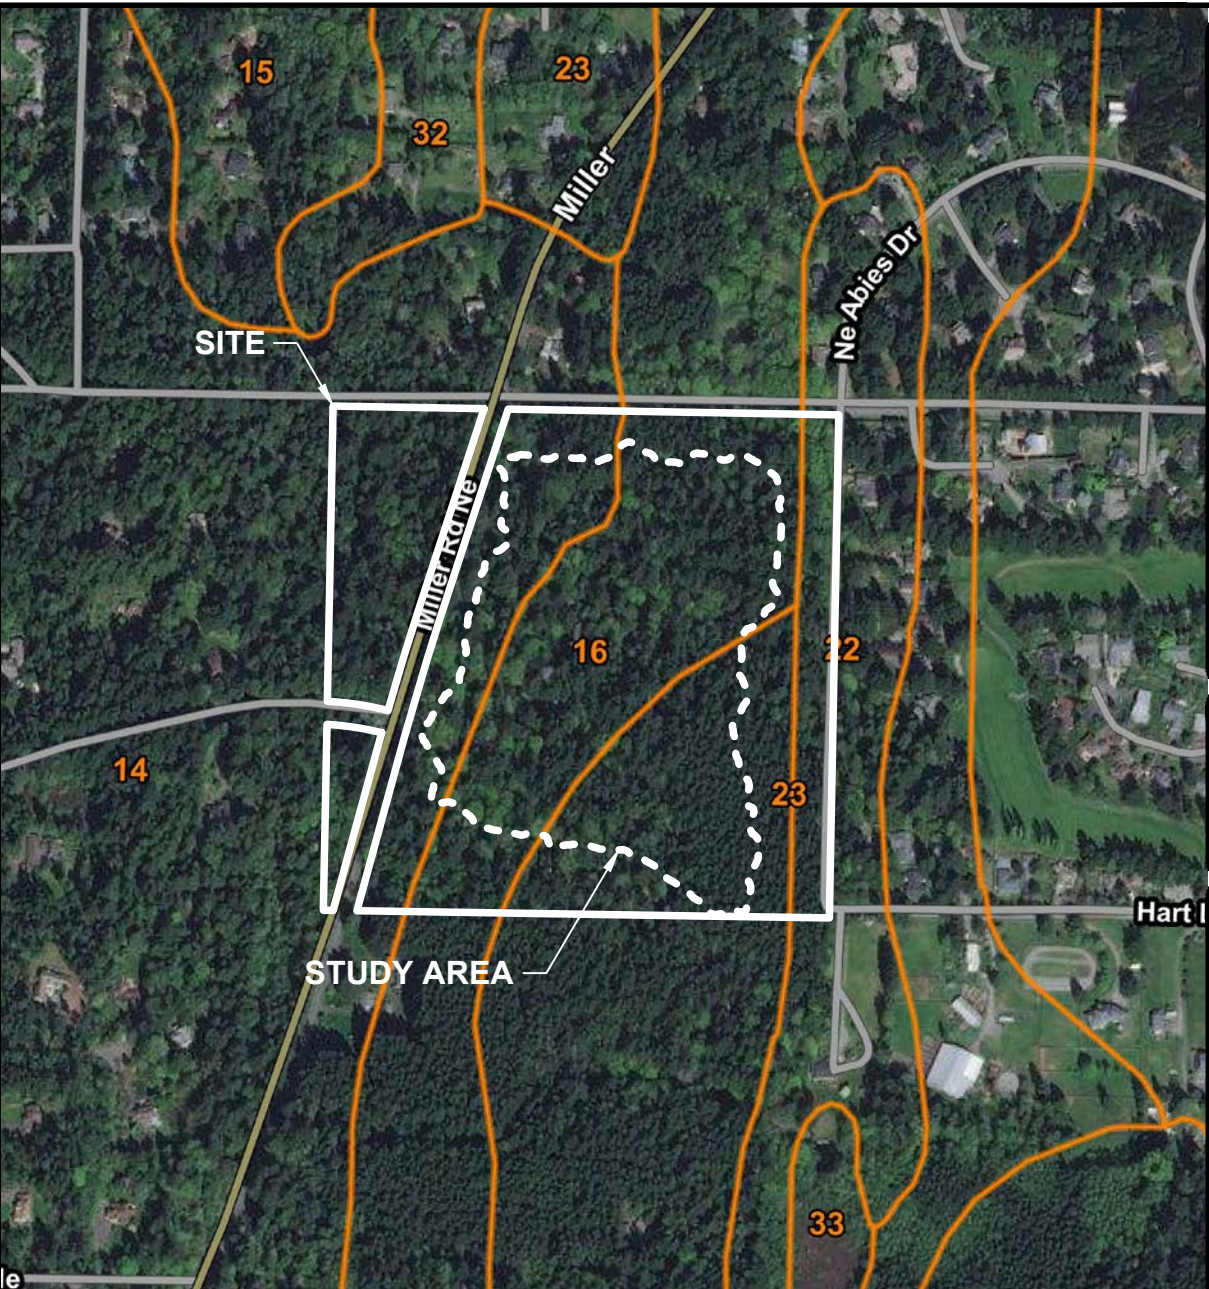
As referenced on the U.S.D.A. Natural Resources Conservation Service (NRCS 2019) website, the soils within the study area include Harstine gravelly ashy sandy loam, 0 to 6 percent slopes (14), Harstine gravelly ashy sandy loam, 15 to 30 percent slopes (16), and Kapowsin gravelly ashy loam, 6 to 15 percent slopes (Figure 3). The soil unit just east of the study area and on the park property is Kapowsin gravelly ashy loam, 0 to 6 percent slopes (22). None of these soil units are classified as hydric (NRCS 2015). Harstine soils are moderately well drained and formed in sandy glacial drift with an influence of volcanic ash over dense glaciomarine deposits. Depth to water table in Harstine soils is more than 80 inches. Kapowsin soils are moderately well drained and formed in volcanic ash mixed with glacial drift over dense glaciomarine deposits. The depth to the water table ranges between 11 and 24 inches below the surface. Areas mapped as hydric soils do not necessarily mean that an area is or is not a wetland—hydrology, hydrophytic vegetation, and hydric soils must all be present to classify an area as a wetland.

- 14** Harstine gravelly ashy sandy loam, 0 to 6 percent slopes. Not hydric.
- 16** Harstine gravelly ashy sandy loam, 15 to 30 percent slopes. Not hydric.
- 22** Kapowsin gravelly ashy loam, 0 to 6 percent slopes. Not hydric.
- 23** Kapowsin gravelly ashy loam, 6 to 15 percent slopes. Not hydric.

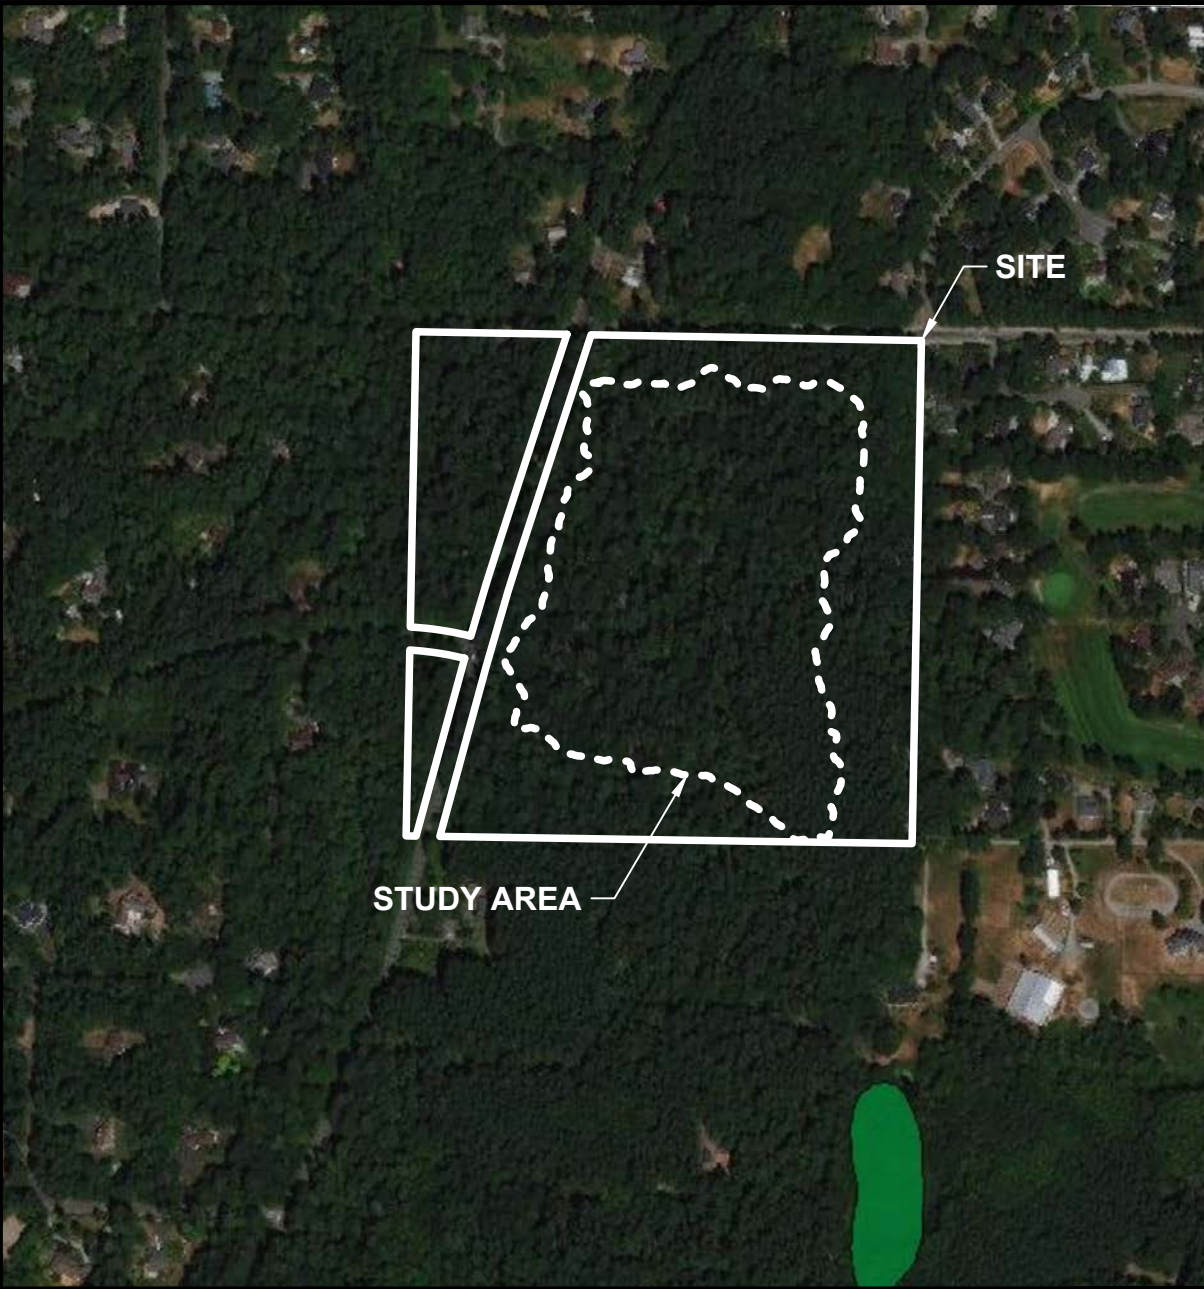
Figure 4  
**NATIONAL WETLANDS INVENTORY MAP**  
 North Grand Forest  
 Bainbridge Metro Parks and Recreation District  
 City of Bainbridge Island, Kitsap County, WA  
 Section 16, Township 25N, Range 2E, W.M.

The U.S. Fish and Wildlife Service (USFWS), National Wetlands Inventory (NWI) map does not indicate the presence of wetlands on or within 300 feet of the property (Figure 4) NWI maps are to be used with discretion because they are intended to gather general wetland information about a regional area and therefore are limited in accuracy for smaller areas due to their large scale. Wetlands were not identified within the study area or the North Grand Forest during the reconnaissance field visit.

No mapped wetlands indicated onsite by US Fish & Wildlife Service.

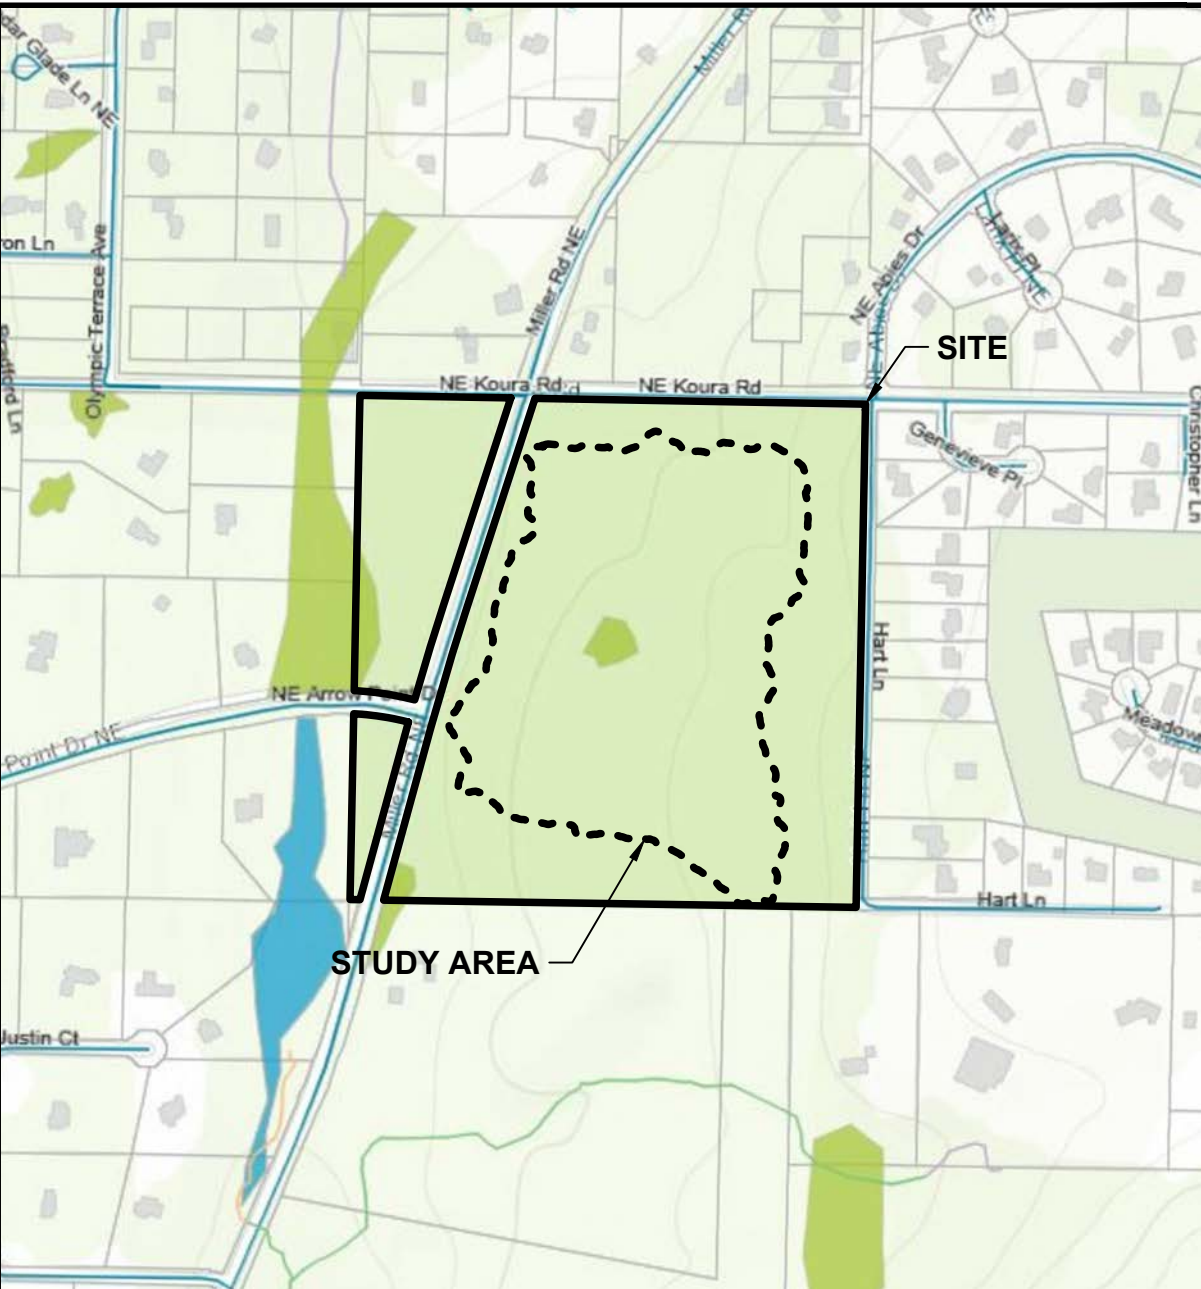
Figure 5  
**BAINBRIDGE ISLAND CRITICAL AREAS MAP**  
 North Grand Forest  
 Bainbridge Metro Parks and Recreation District  
 City of Bainbridge Island, Kitsap County, WA  
 Section 16, Township 25N, Range 2E, W.M.

The Bainbridge Island Critical Areas Web Application (BI 2019) maps a small wetland near the middle of the west half of the study area (Figure 5). The wetland was not observed during the field reconnaissance as verified at Test Plot 4, which is located near the northern tip of the mapped wetland (Figure 2). The test plot data revealed that there were no positive indicators for any of the three wetland parameters and no wetlands in this area as mapped. Critical area maps are to be used

with discretion because they are intended to gather general wetland information about a regional area and therefore are limited in accuracy for smaller areas due to their large scale.

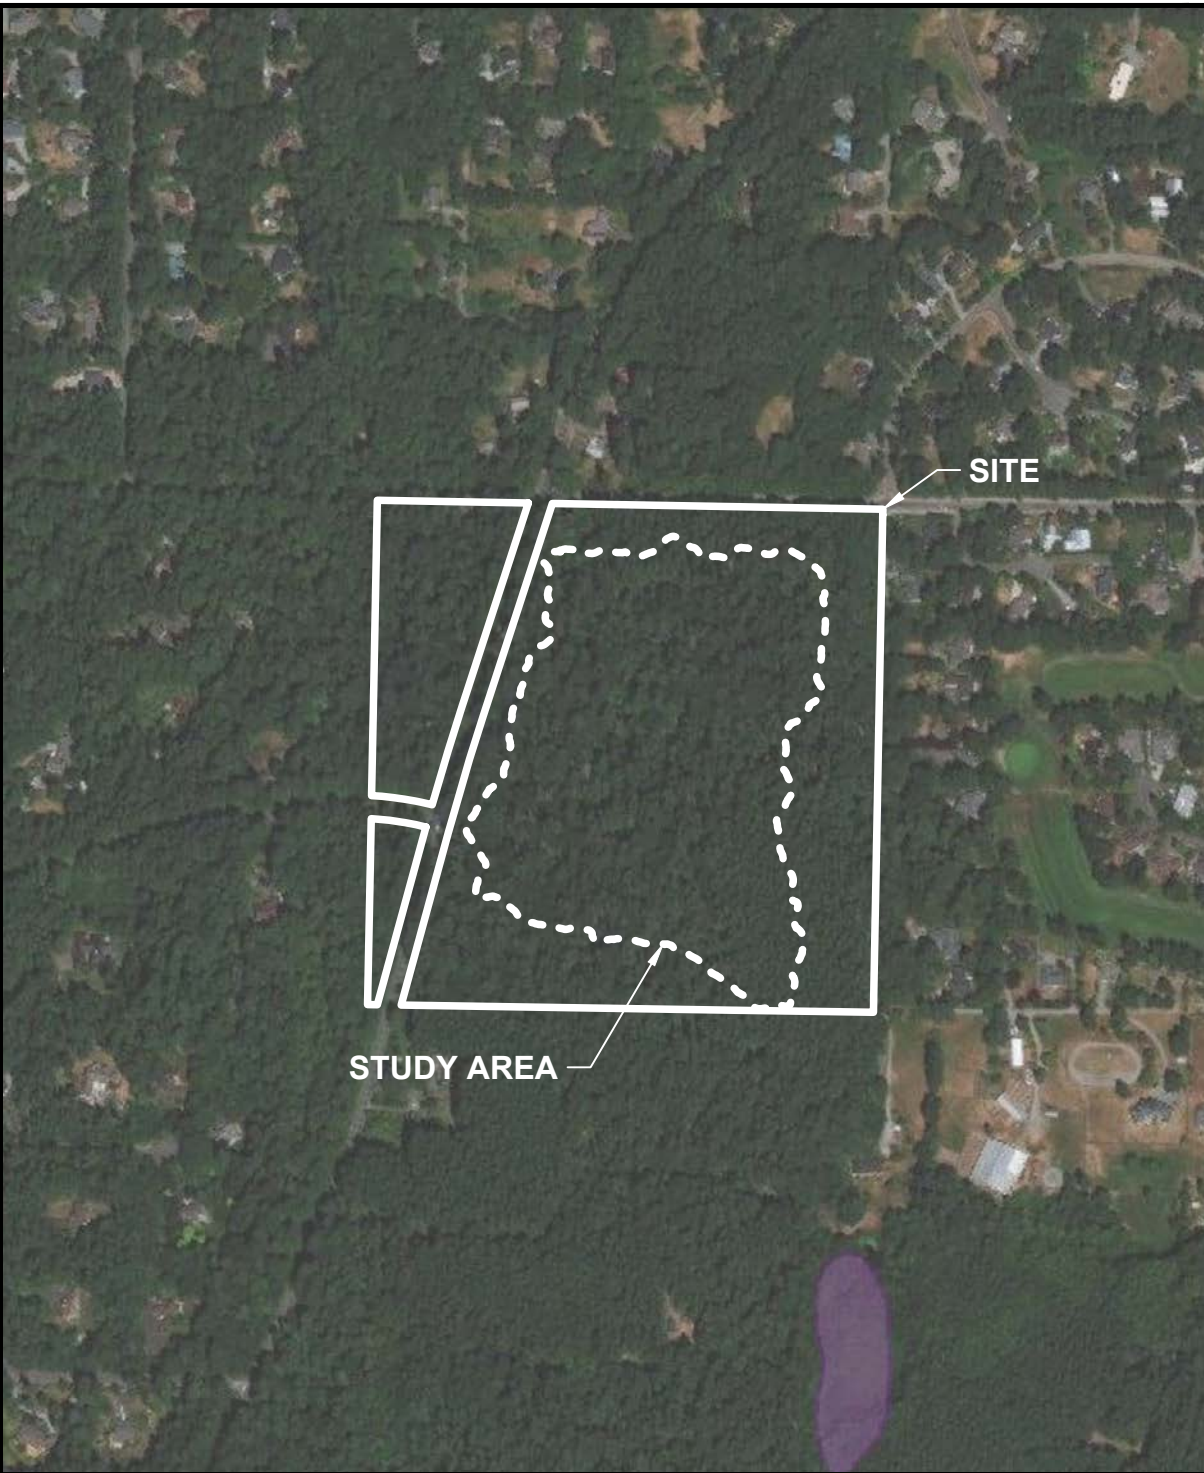
**Figure 6**  
**PRIORITY HABITAT AND SPECIES MAP**  
North Grand Forest  
Bainbridge Metro Parks and Recreation District  
City of Bainbridge Island, Kitsap County, WA  
Section 16, Township 25N, Range 2E, W.M.

The Washington Department of Fish and Wildlife (WDFW) Priority Habitat and Species (PHS) website (WDFW 2019) identifies and maps priority habitat and species areas in the state of Washington. The PHS map shows no priority habitats or species on or near the North Grand Forest (Figure 6).

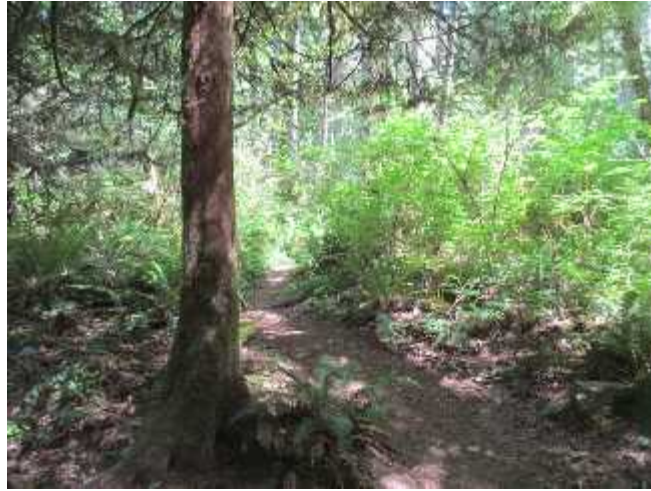
**Photo 1** was taken from the northwest corner of North Grand Forest. It looks east along the northern section of the perimeter trail. This photo shows an area of dense salmonberry that does not meet the wetland criteria.

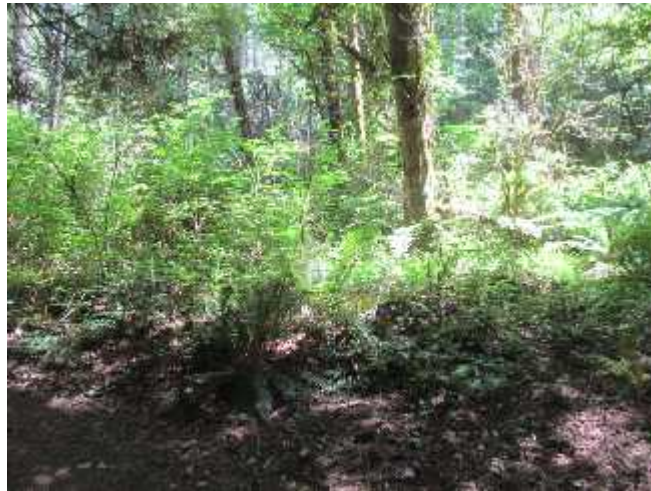
**Photo 2** was taken from the same location as Photo 1. It looks southeasterly into the forested study area from the trail.

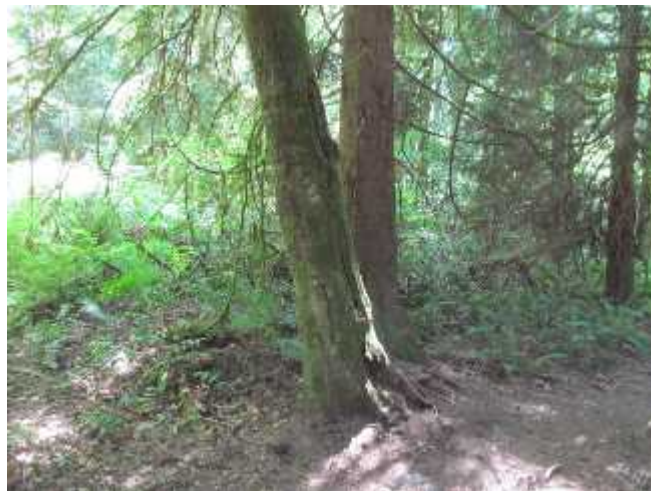
**Photo 3** was taken from the same location as Photos 1 and 2. It looks into the forested study area along the north side of the park.

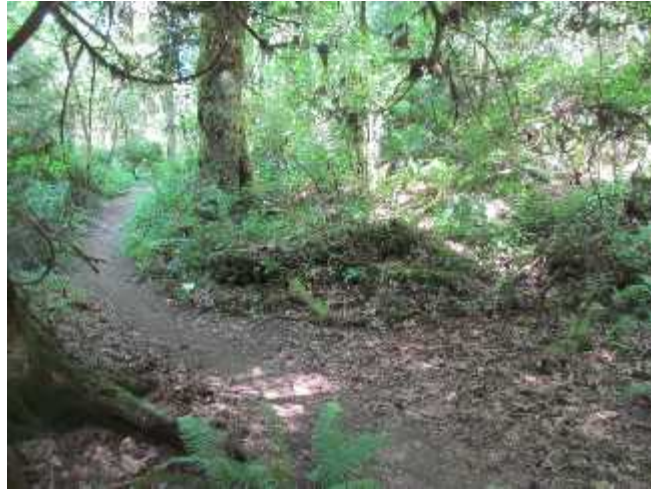
**Photo 4** was taken from near the southwest corner of the North Grand Forest and it looks north along the western portion of the perimeter trail. The conditions in this photo are indicative of the views of the forested study area from the trail.

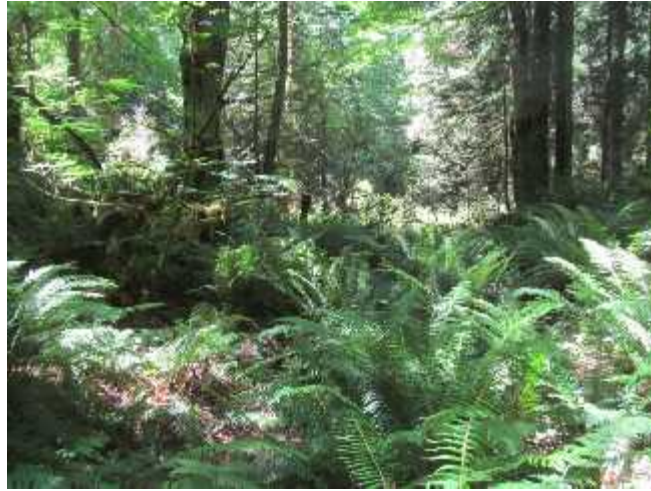
**Photo 7** provides a view of the forest that lies within the interior of the park as viewed from the perimeter trail. Many areas are dominated by conifer trees with sword fern dominating the understory, so this photo is typical of the forested conditions within the study area.

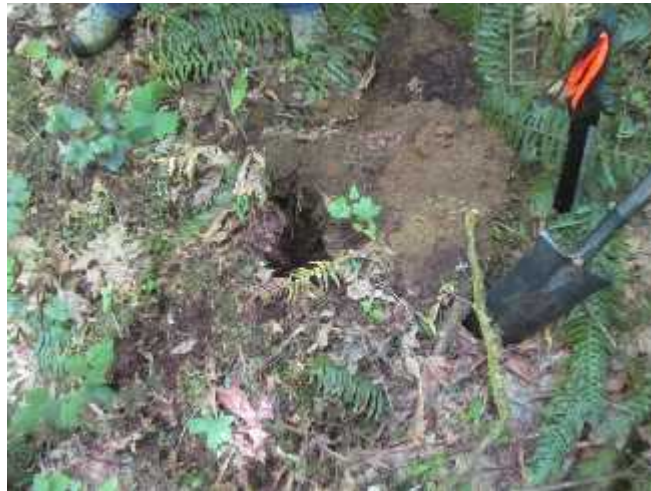
**Photo 8** shows the soil at one of the eight test plots conducted across the North Grand Forest. The soil was composed of gravelly sandy loam with dark brown to reddish brown chromas that met none of the hydric soil indicators.

Gravelly sandy loam soil profiles were revealed at seven of the eight test plots and generally consisted of two layers with a 2 to 7-inch surface layers that had brown (10YR 2/2) matrix chromas. The subsurface layer had red to reddish brown (7.5YR 4/6 to 10YR 4/6) matrix chromas. A three-layer profile was revealed at Test Plot 8 and consists of a 2-inch brown surface layer (10YR 2/2), a 6-inch light brown intermediate layer (10YR 3/3), and a bottom layer with a red (10YR 4/6) matrix chroma. The soil profiles revealed at the eight test plots did not meet any of the hydric soil indicators because of high matrix chromas.

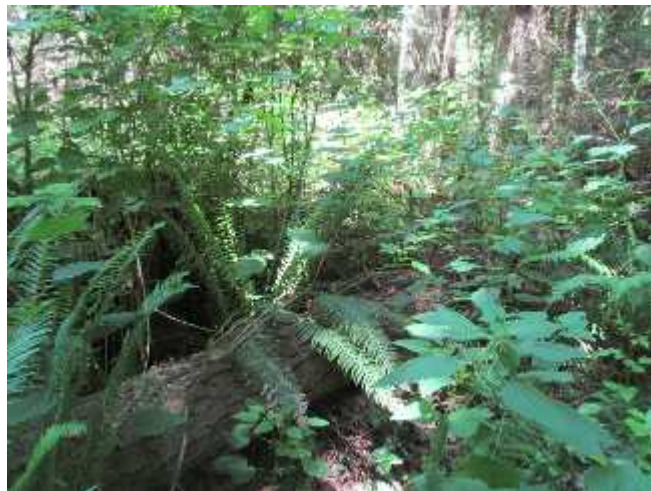
**Photo 9** shows an area of the forest where salmonberry dominates the shrub layer. Test plots were completed in some of these areas and no wetland conditions were observed. This photo is indicative of areas where the canopy is more open, and a high shrub layer has developed.
