CRITICAL AREAS REPORT

North Grand Forest *Bainbridge Island, Washington*

Prepared for
**Bainbridge Island Metropolitan
Parks and Recreation District
7666 NE High School Road
Bainbridge Island, WA 98110
(206) 842-2306**

Prepared by
Ecological Land Services
1157 3rd Avenue, Suite 220A • Longview, WA 98632
(360) 578-1371 • Project Number 2248.08

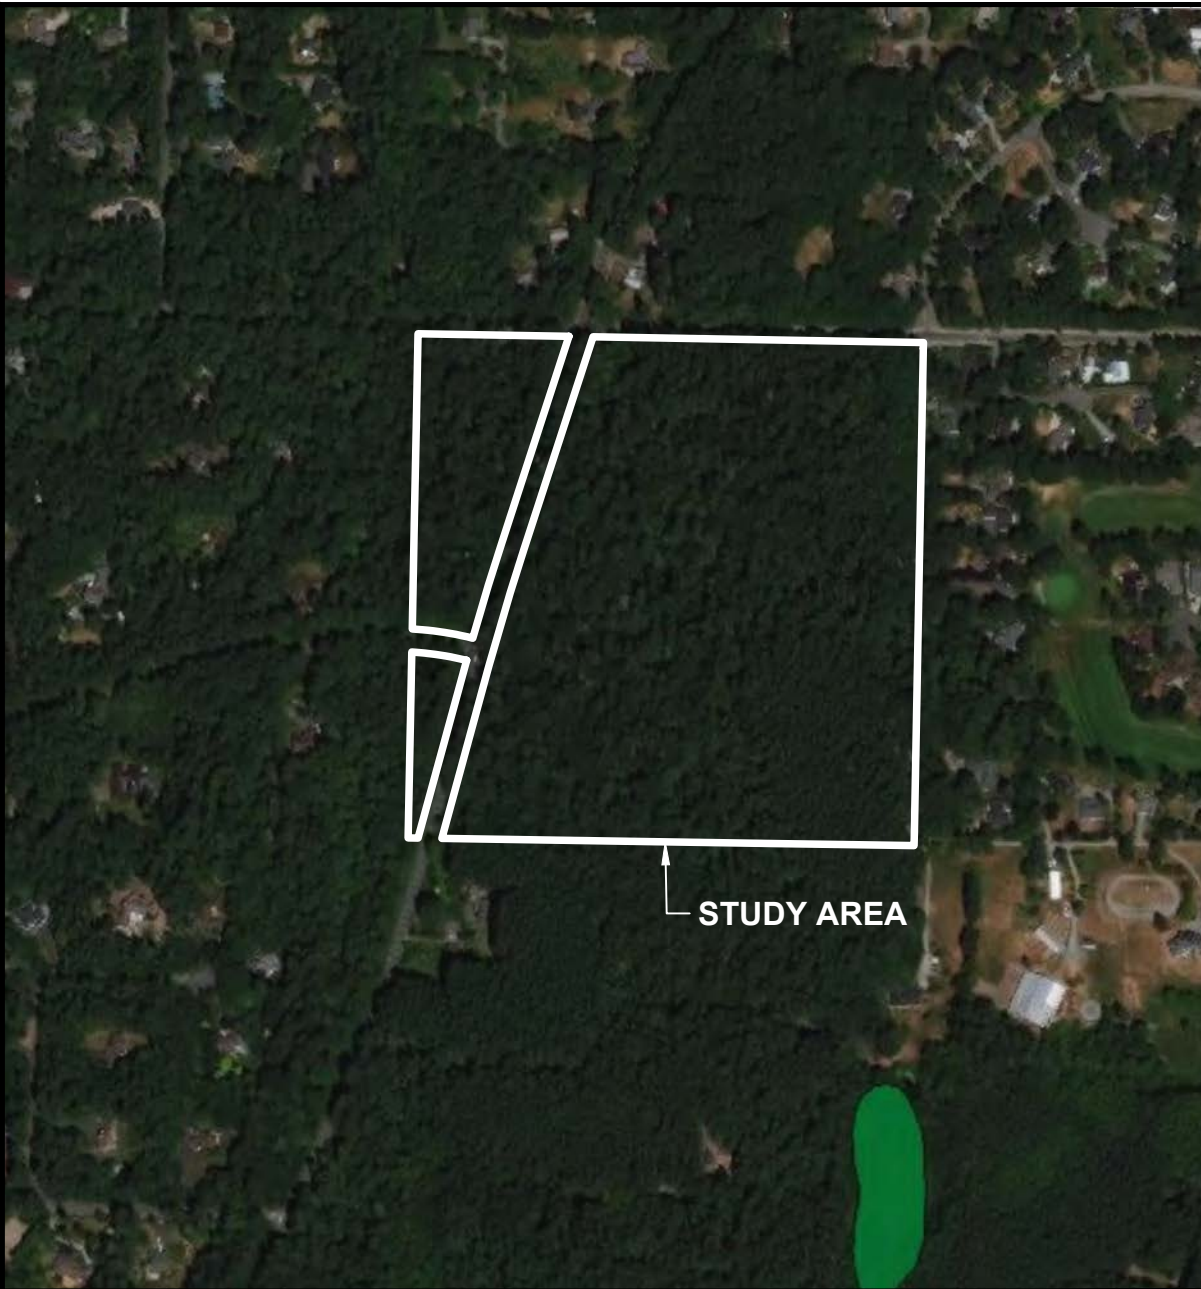
Figure 5

No mapped wetlands indicated onsite by US Fish & Wildlife Service.

USFWS NATIONAL WETLANDS INVENTORY
North Grand Forest Wildlife Study
Bainbridge Island Metro Parks and Recreation
City of Bainbridge Island, Kitsap County, Washington
Section 16, Township 25N, Range 2E, W.M.

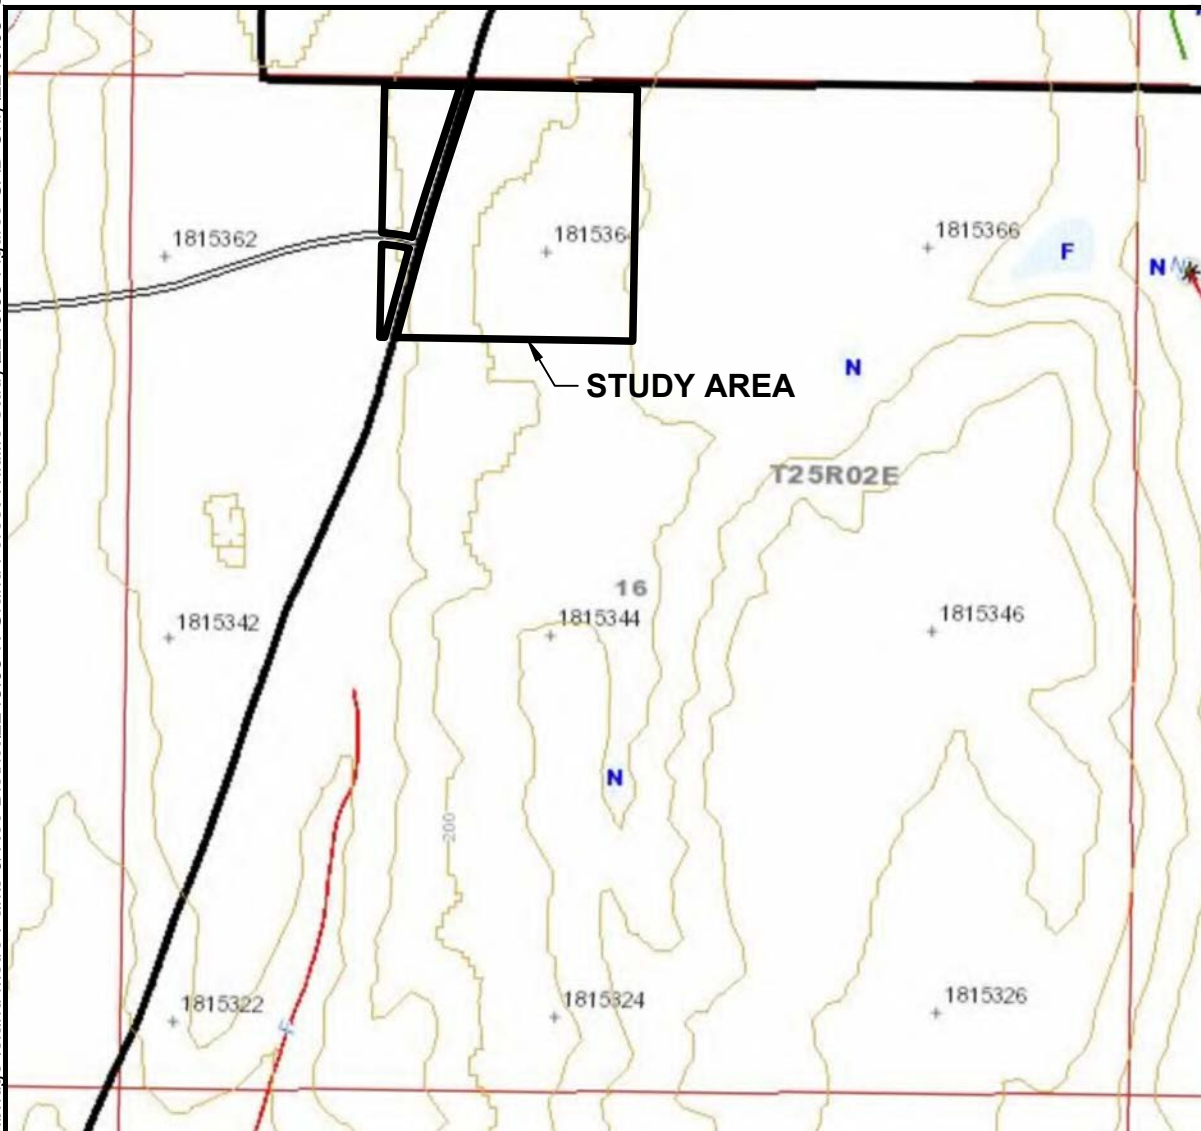
No mapped streams indicated onsite by the Washington State Department of Natural Resources (DNR).

The Washington State Department of Natural Resources (WDNR 2021) Forest Practices Application Mapping Toole (FPAMT) water type mapping website does not indicate the presence of streams on or within 200 feet of the study area (Figure 6). Streams were not identified in the depressional troughs that extend down the moderate slopes because there were no indicators of water flow observed.

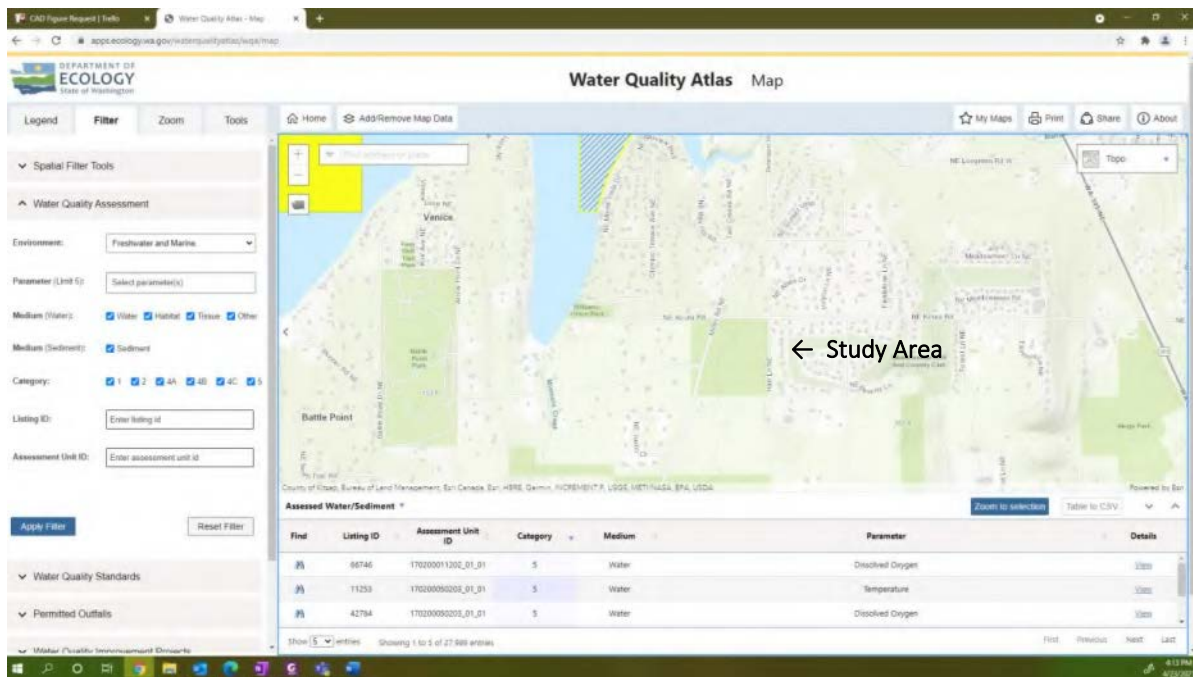
Figure 11a-303(d) Map: The wetland does not discharge into a 303(d) listed water within 1 mile.

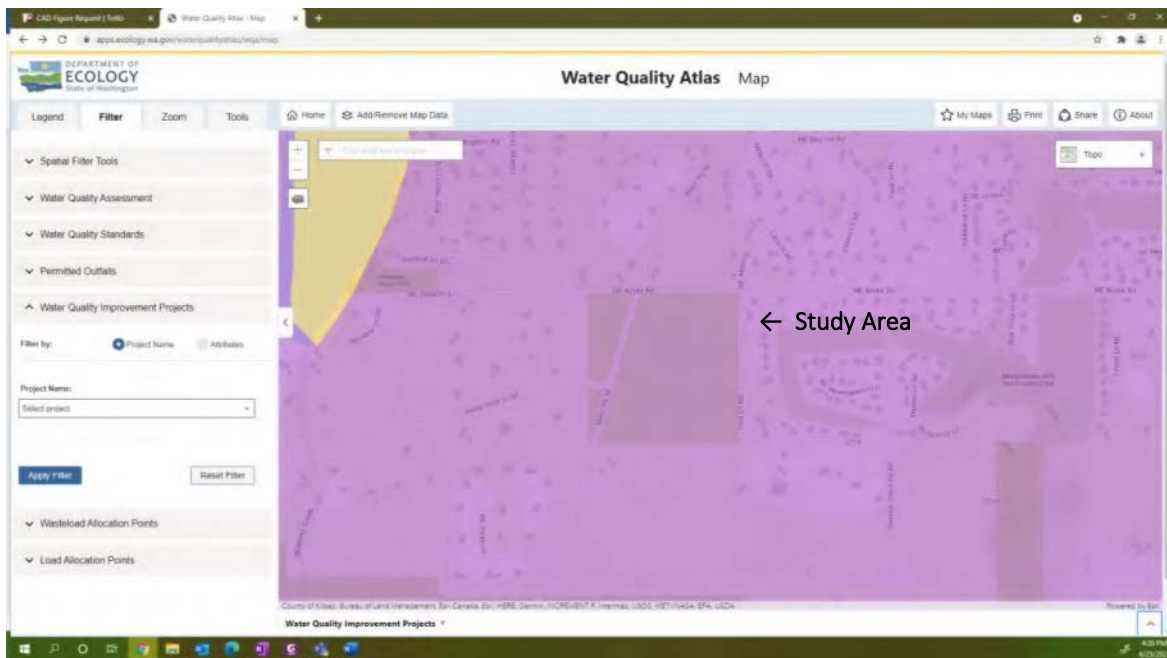
Figure 11b: TMDL for Study Area.

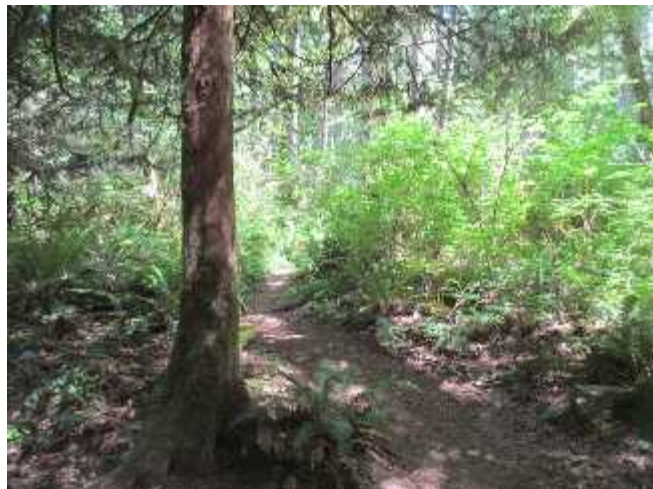
Photo 1 was taken from the northwest corner of North Grand Forest. It looks east along the northern section of the perimeter trail. This photo shows an area of dense salmonberry that does not meet the wetland criteria.

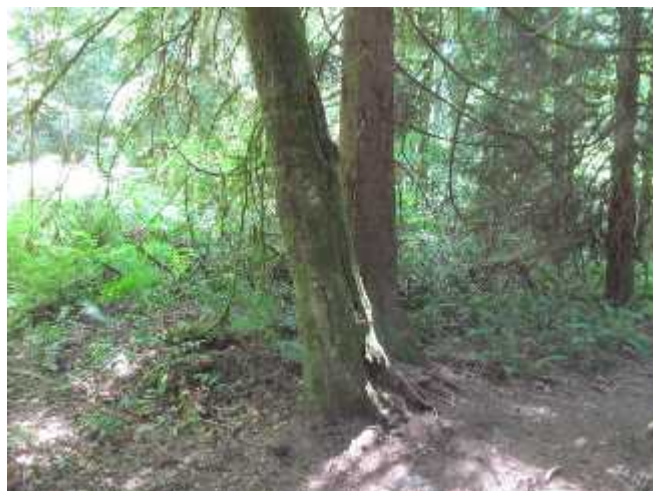
Photo 2 was taken from the same location as Photo 1. It looks southeasterly into the forested study area from the trail.

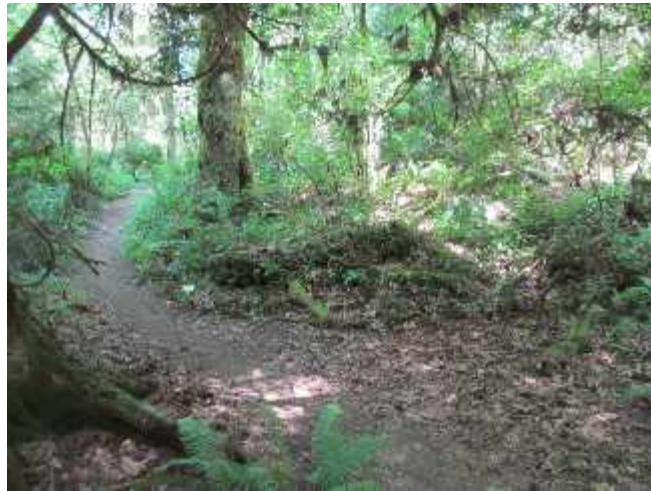
Photo 4 was taken from near the southwest corner of the North Grand Forest and it looks north along the western portion of the perimeter trail. The conditions in this photo are indicative of the views of the forested study area from the trail.

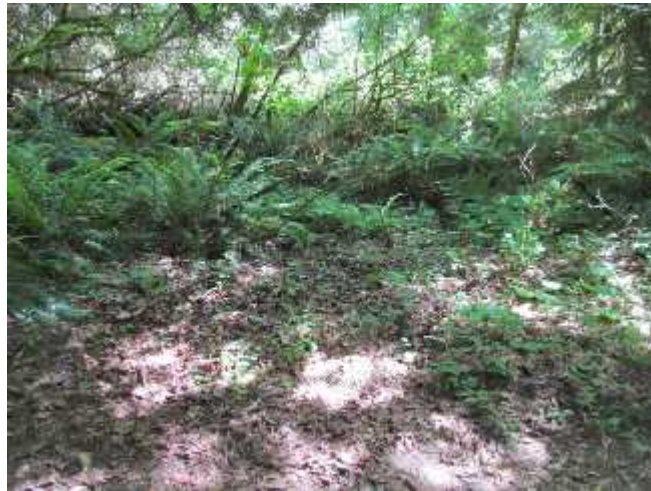
Photo 5 was taken from the southern portion of the perimeter trail and shows an area of the forest that lacks dense shrub cover.

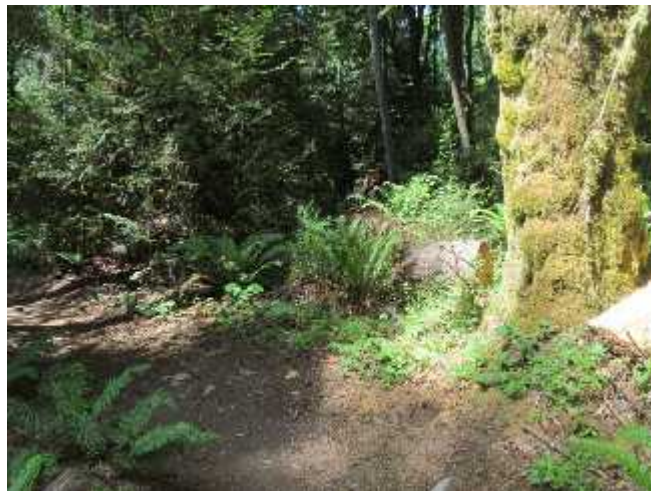
Photo 6 was taken along a section of the perimeter trail on the North Grand Forest. In this photo, bigleaf maple is present in the canopy with sword fern dominating the understory.

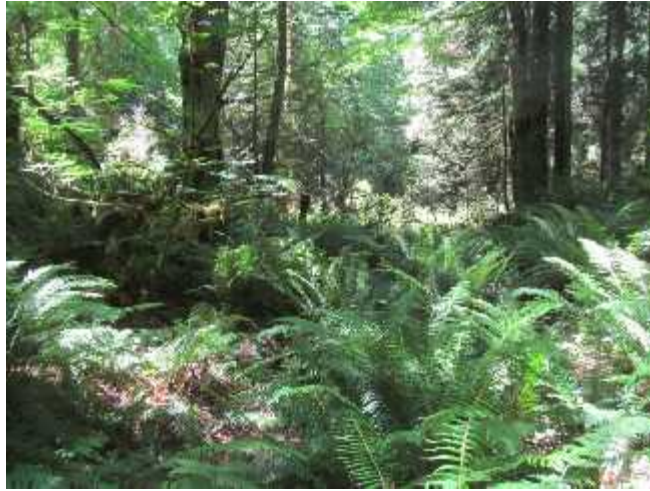
Photo 7 provides a view of the forest that lies within the interior of the park as viewed from the perimeter trail. Many areas are dominated by conifer trees with sword fern dominating the understory, so this photo is typical of the forested conditions within the study area.

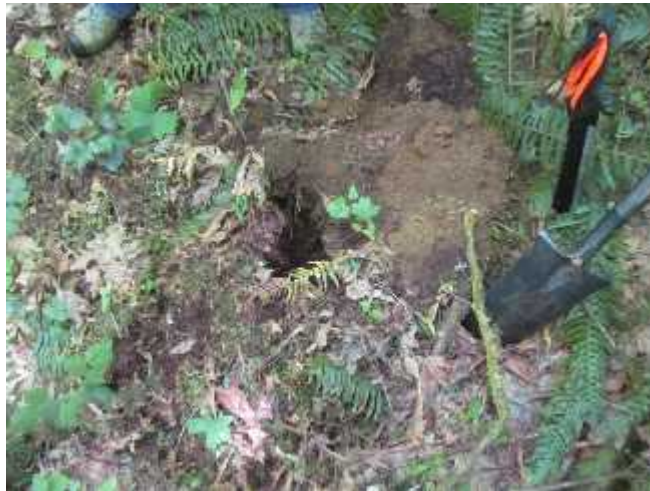
Photo 8 shows the soil at one of the eight test plots conducted across the North Grand Forest. The soil was composed of gravelly sandy loam with dark brown to reddish brown chromas that met none of the hydric soil indicators.

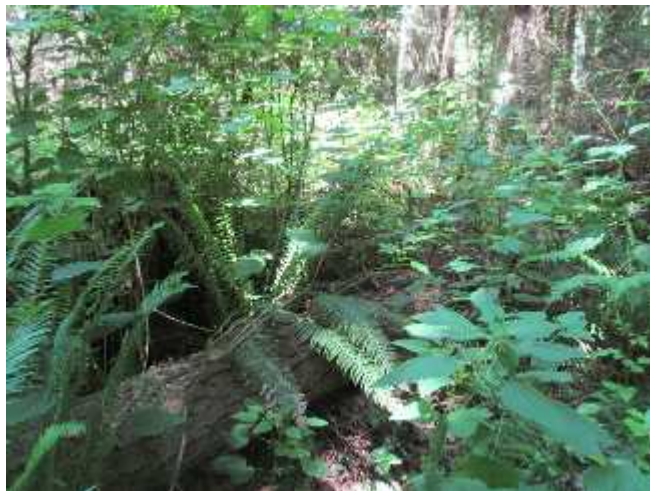
Photo 9 shows an area of the forest where salmonberry dominates the shrub layer. Test plots were completed in some of these areas and no wetland conditions were observed. This photo is indicative of areas where the canopy is more open, and a high shrub layer has developed.

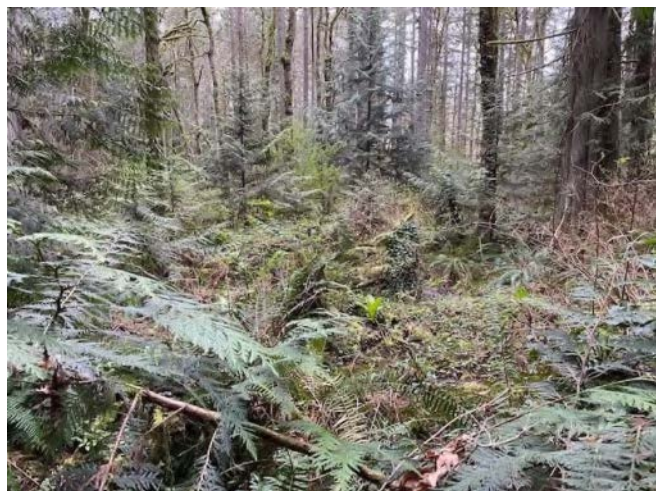
Photo 10 was taken of Wetland A from the west end. The wetland is fairly indistinguishable from the upland that surrounds it but it is present in the middle right where the shrub and herbaceous vegetation is the most dense. The wetland is a mosaic so there are high upland areas within the delineated boundary.

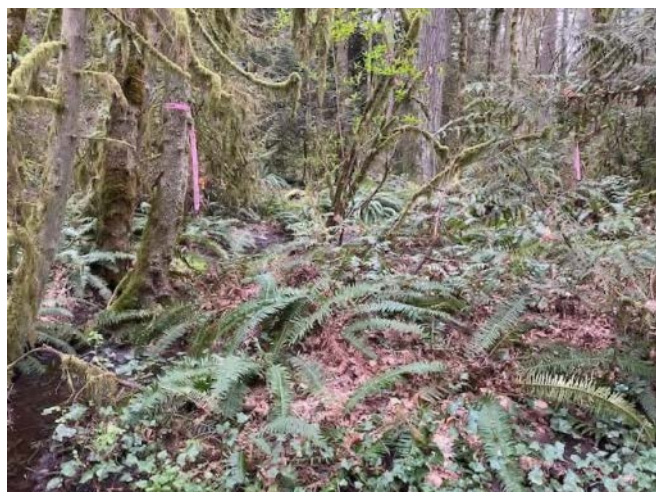
Photo 11 was taken from the same location as Photo 10 and looks easterly across the upland toward the delineated boundary. Flags are visible on the left side and in the right background at the edge of the wetland.

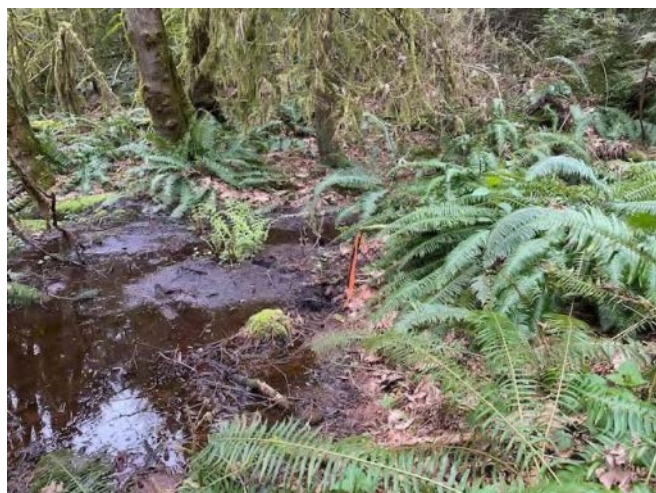
Photo 12 was taken of the area where Test Plot 11 was conducted. It is located at the edge of an occasionally flooded area at the north end of Wetland A. The soil hole was dug at the edge where the orange flag is located but includes the entire bare area of the wetland.

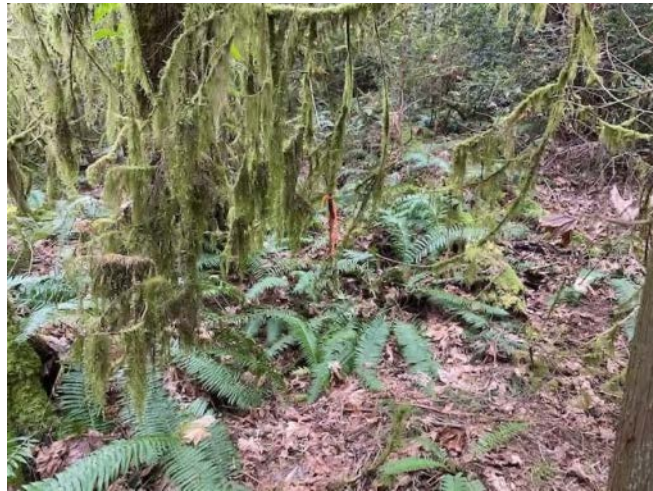
Photo 13 was taken of the area where Test Plot 10 was conducted. It is located on the northeast side of Wetland A and outside of flag WB A-2. This area is upland because there were no positive indicators present for any of the three wetland parameters.

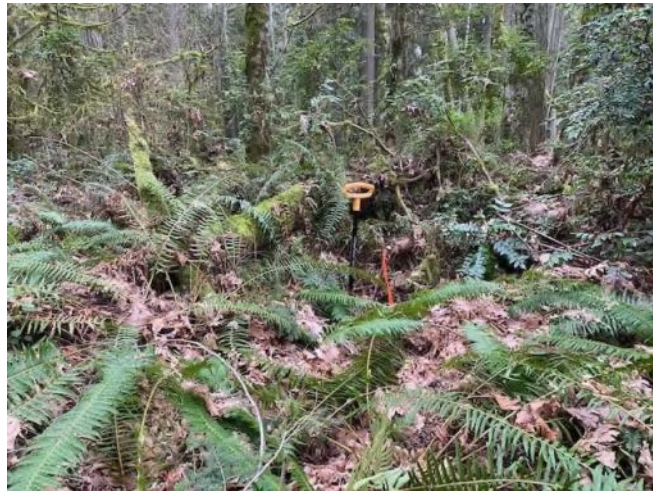
Photo 14 was taken of the area where Test Plot 12 was conducted. This test plot is located southwest of Wetland A in upland outside of flag WB A-15. This area was determined to be upland because there were no positive indicators present for any of the three wetland parameters.

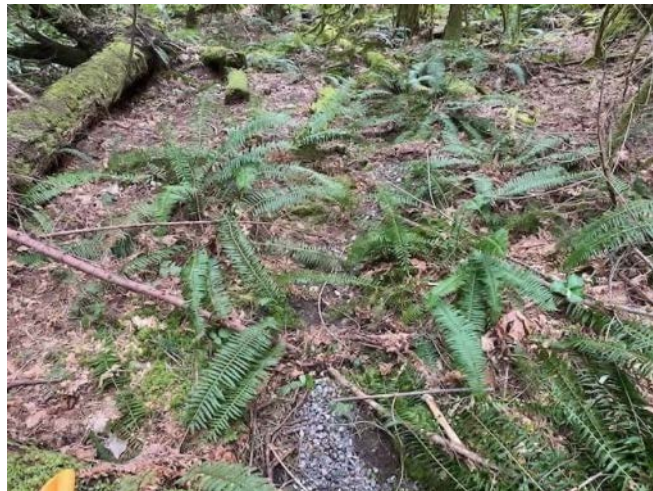
Photo 15 was taken from the northern segment of the perimeter trail. It looks north from the trail to document the conditions of the ephemeral drainage as it extends to Koura Road. There was no water in most of the channel because it dissipates about 100 feet west of its outlet from Wetland A.
