**Bainbridge Island Metropolitan Park & Recreation District
Regular Board Meeting 6:00 pm
Thursday – February 16, 2023**

**RAY WILLIAMSON POOL
COMPREHENSIVE CONDITION REPORT
BAINBRIDGE ISLAND METRO PARK & RECREATION DISTRICT
PROJECT NO.: 2208 FINAL DRAFT**

Stemper Architecture Collaborative and the consultant team (Stemper AC Team) performed a comprehensive condition assessment (CCA) of the Ray Williamson Pool (RWP) at Bainbridge Island Aquatic Center (BIAC) for Bainbridge Island Metropolitan Park and Recreation District (BI Parks). The site visit took place on September 14, 2022 in which the Stemper AC Team reviewed all building systems and components at the exterior and interior including but not limited to: building envelope systems such as roof and wall assemblies, window systems, major and minor structural systems, mechanical, electrical, and plumbing/drainage systems. Building usage, wear and tear, and areas of concern/interest were also reviewed along with concrete pool deck and paving, pool equipment/auxiliary use items, pool gutter and liner system, general review for moisture intrusion, and review for accessibility compliance (ADA). Additionally, the Stemper AC Team ens

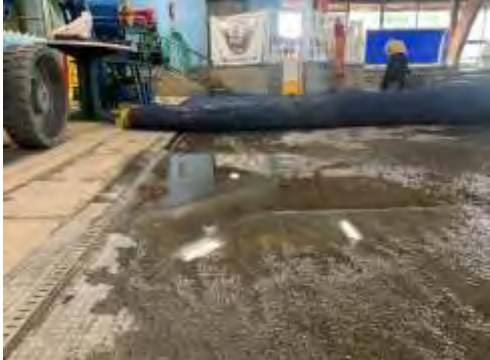
Description	Photo
<p>1. Inadequate slope of pool deck and management of deck mats <u>Deficiency:</u> <i>Insufficient slope to trench drains</i> <u>Recommendation:</u> <i>Excavate concrete and replace trench drains at areas where ponding is occurring.</i></p>

1. Inadequate slope of pool deck and management of deck mats

The pool deck is covered by walking mats, which reduce the risk of guests slipping compared with untreated bare concrete. Beneath the mats there is evidence that the concrete surface is not sloped adequately to avoid small amount of water to pond rather than flow to the floor drains as intended. To avoid health issues and maintain a clean and sanitary pool deck, the maintenance staff rolls up the mats each evening and cleans the floor. This routine tedious task can be eliminated by removing defective and unbonded concrete deck and provide an overlay sloped adequate for water to flow toward the trench drains and with surface roughness adequate to mitigate the slipping hazard.

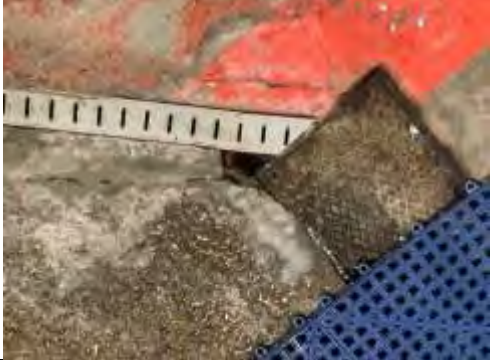
<p>2. Scaled and cracked concrete at pool deck <u>Deficiency:</u> <i>Concrete deterioration, some local delamination and small cracks in a few places.</i> <u>Recommendation:</u> <i>Remove deteriorated surfaces, prepare surface, and provide polymer modified overlay. Pressure-inject cracks.</i></p>

2. Scaled and cracked concrete at pool deck (Figure 2)

Scaling of concrete surfaces, delamination, and cracks will allow chlorine water to penetrate the concrete, corrosion to occur in the rebar, and water to seep into the ground beneath the concrete deck. Repairing these defects will extend the life of the structure and reduce future maintenance costs.

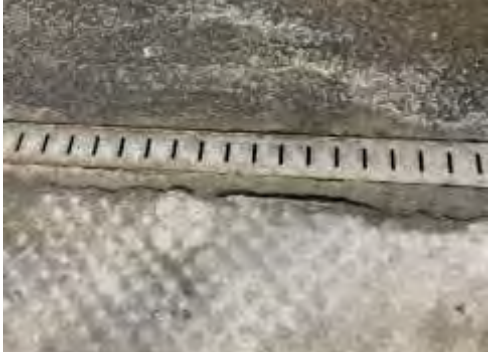
<p>3. Deterioration at trench drain <u>The linear trench drain extends around the entire pool. The drain is reportedly working as intended.</u> <u>Deficiency:</u> <i>Cracked grout edging and missing components at trench drain</i> <u>Recommendation:</u> <i>Remove deteriorated surfaces, and, prepare surfaces. Provide new edging grout where loose. Install new portions of trench drains were missing.</i></p>

3. Deterioration at trench drain

The FRP perimeter trench drain appears to have become brittle, with pieces broken or missing from the drain and grout around the drain failing. To improve the effectiveness of the drain in removing water from the concrete deck and reducing a safety hazard from broken FRP at the walking surface, the concrete can be cut on each side of the drain, the drain removed and replaced, and new non-shrink moisture resistant grout place continuously around the new drain.

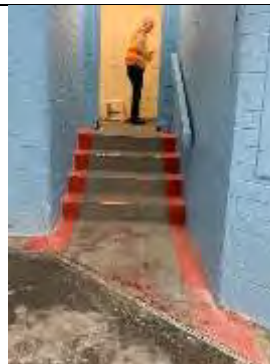
Deficiency: Concrete deterioration apparently due to chlorine exposure

4. Corrosion and scaling at south end steps

A local area of deteriorated concrete and corroded rebar exists at the south end of the pool where steps lead to an un-used locker room. Water seepage into the concrete has caused some local corrosion of rebar and spalling of the concrete surface. The repair needs to include removal of all disbonded and cracked concrete, replaced with a water-resistant concrete that has corrosion inhibitor and galvanic anodes where excavation is deeper than approximately 2 inches.

Recommendation: Excavate deteriorated concrete, prepare surface, and provide overlay polymer modified overlay

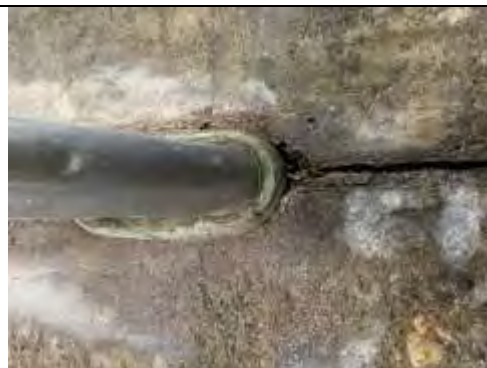
Deficiency: Concrete deterioration apparently due to chlorine exposure

5. Deterioration at post base at railing

The post base that supports a handrail near the southeast portion of the pool has concrete failing along a control joint in the concrete deck slab. The base material at the post is also deteriorated. The entire railing and base will likely need to be removed and refurbished or replaced. The concrete at the base needs to be excavated, a new post base connection provided, and the concrete locally patched in this area. This repair can be done in conjunction with deck overlay work or done as a stand-alone repair, depending on the extent of the mitigation work selected.

Recommendation: Excavate concrete to sound material, replace railing and post base, and patch concrete locally at repair area.

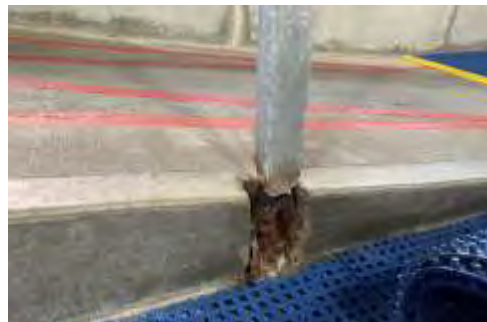
6. Steel post at ramp guardrail

Deficiency: Corrosion at galvanized steel post

6. Corroded steel post at ramp guardrail

Significant corrosion has damaged the galvanized steel post that supports the guardrail along the southwest concrete ramp. The post and rail system needs to be removed and replaced with stainless steel for a more durable and lasting solution than the current galvanized steel. The concrete needs to be excavated to expose the connection and deteriorated concrete, the new rail and post reconnected, and the concrete patched.

Recommendation: Removed the post from the rail, excavate the damaged concrete and connection. Replace the post and reconnect to the concrete; then patch the concrete at the post base.

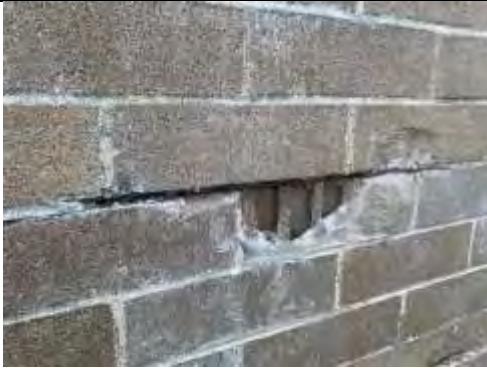
<p>7. Brick and mortar damage</p> <p><u>Deficiency:</u> Broken bricks, missing faceshells, and deteriorated mortar throughout. Not all damage could be observed, although efflorescence staining from moisture intrusion is seen at many locations along with evidence of previous repairs of mortar and reinforcing.</p> <p><u>Recommendation:</u> Remove damaged brick and K-web reinforcing where corroded and replace. Remove mortar throughout the building envelope, repoint, clean and seal all brick to protect against further moisture intrusion.</p>

7. Brick and mortar damage

The majority of the building envelope where glazing does not occur is formed with brick over CMU block. Due to the age of the mortar, the extensive wear and deterioration, and the exposure of moisture to the reinforcing K-web bars, the brick mortar needs to be removed, reinforcing exposed and replaced where corroded, and the mortar replaced on the exterior. Cleaning and sealing of all brick is required to provide durability and protection against future moisture intrusion. Broken and damage brick needs to be removed and replace at local areas.

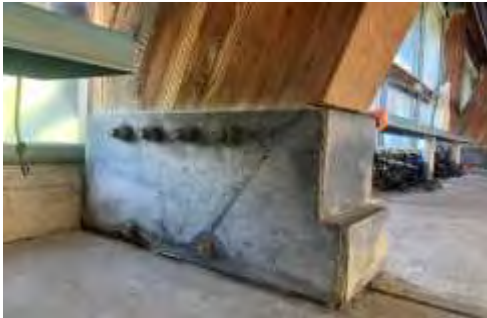
<p>8. Corrosion at glu-lam base connections</p> <p><u>Deficiency:</u> Galvanized GL beam bases have spots of corrosion at some locations.</p> <p><u>Recommendation:</u> Removed corrosion from bolts, nuts and plates or replace as required.</p>

9. Corrosion at glu-lam base connections

There is a small amount of corrosion and concrete deterioration at a galvanized base for the curved glu-lam based attachment to the concrete deck. As part of the refurbishment and for the purpose of extending the life of the structure, the concrete needs to be removed where signs of spalling and delaminated concrete exist. The corrosion in the steel base can be removed by grinding and re-coated with a galvanized paint and potentially epoxy coating as determined suitable by the Owner and Architect. Any bolts with evidence of corrosion need to be replaced in kind or with stainless steel bolts separated from the galvanized steel with nylon washers.

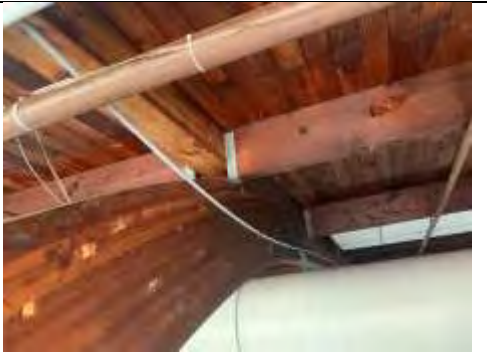
<p>9. Glu-lam beam and wood decking roof faming</p> <p><u>Findings:</u> <u>Glulam wood arch beams and timber T&G decking support the semi-arched clear-span over the natatorium.</u> Where the framing was observed up close and soundings made, the glulam beams were found to be in good condition with no signs of deterioration or structural cracking at the laminations.</p> <p><u>Recommendations:</u> No work required. Improved ventilation will help reduce risk of future damage.</p>

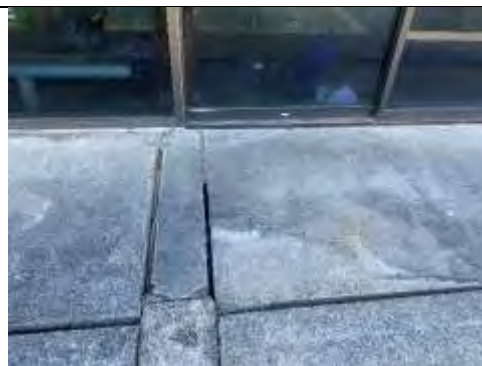
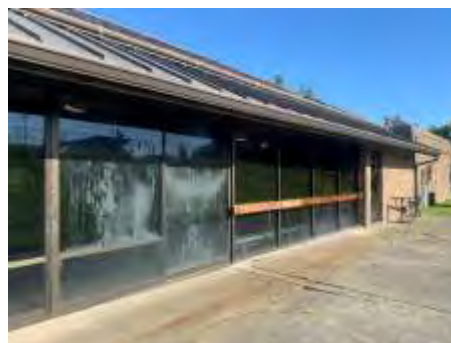
10. Exterior concrete walkways

Deficiency: Concrete is cracked, settled, and joint material missing.

10. Repair at exterior concrete walkways (Figure 3)

Numerous portions of the concrete slab-on-grade are cracked, heaved, and causing a tripping hazard. Repair of these areas can be made by removing the concrete and a portion of subgrade, then replacing the soil with granular fill and replacing the concrete using control joints to match existing

Recommendation: Remove deteriorated concrete and approximately four inches of soil, provide granular fill and replace concrete and joints.

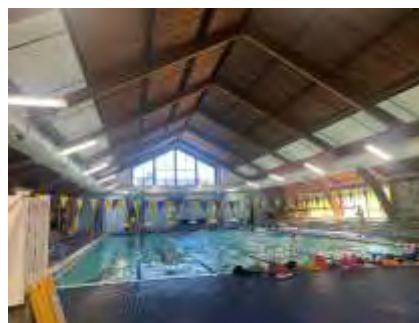
Deficiency: Pool at north end is too shallow for swimmer's turn

11. Inadequate depth of pool at shallow end (Figure 4)

The shallow end of the pool is approximately three feet deep, inadequate for competition swimming wear a swimmer's turn is required. The challenge with deepening the pool is bracing and underpinning the existing wall during construction. The wall as designed may not have adequate reinforcing and strength to resist the lateral soil induced loads. Bracing would be required, and a thicker wall and larger footing designed to resist great loads from the taller retaining wall. To provide a smooth transition between the deeper end at the south side of the pool and the retrofit at the north side, the construction would likely start at mid-pool length. Excavation of soil, a new compacted sub-base, and re-casting of the reinforced concrete pool bottom

would be required. Coatings on the concrete and replacement of existing features would be provided as required.

Recommendation: Shore the concrete walls and underpin. Excavate concrete from pool mid-length and remove concrete and soil as required to reach desired depth of approximately five feet. Compact soil and place new concrete and with water barriers, waterstops and aquatic concrete mix. Finish to match existing.

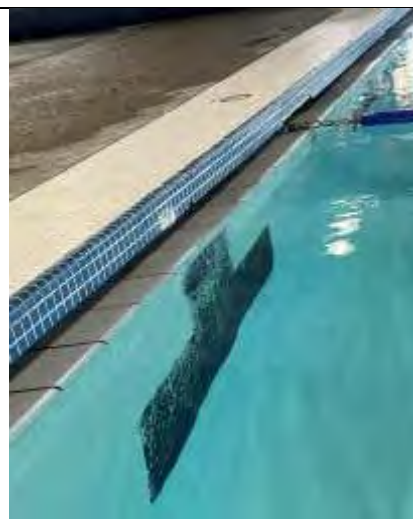
Deficiency: the existing lane markers in the pool tank are worn and fading. The line dividers are attached inside the pool gutter – challenging to install.

Recommendation: paint lane markers; owner requested to install lane divider anchors on the pool wall.

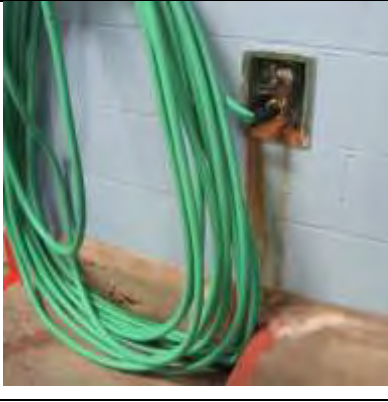
<p>10. Hose bib on northeast wall</p> <p><i>Deficiency:</i> the existing hose bib on the northeast wall of the storage room is corroded. Rust drips have appeared over time.</p> <p><i>Recommendation:</i> repair leak at hose pipe (could be a gasket replacement); replace corroded hose bib housing assembly, and seal the flanges at face of cmu wall.</p>

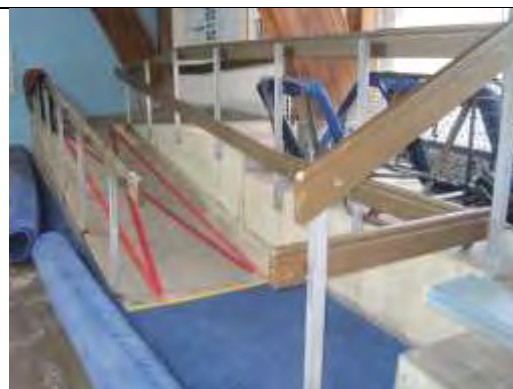
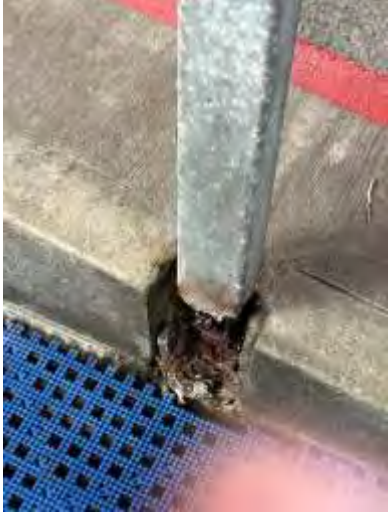
Deficiency: some existing vertical posts at handrails are corroded and handrail is showing age from long term use, constant use of the pool over time has caused the concrete surfacing to erode at the ramp landing and pitting and exposed aggregate are visible. Handrail paint is peeling. Handrail also needs to be detached from the storefront system.

Recommendation: replace handrail and post system with corrosion resistant one (eg: stainless steel) and redesign to be a stand alone handrail. Consider filling and levelling the pitted areas and place a skid-resistant urethane or PMMA type coating system over the ramp and landing.

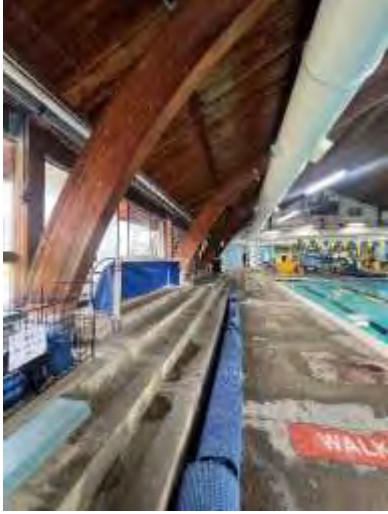
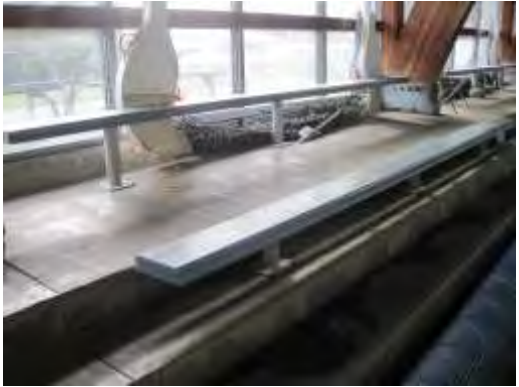
<p>18. Pool deck steps on east and west sides <i><u>Deficiency:</u> bench steps are not ADA compliant and do not provide an accessible spectator area.</i> <i><u>Recommendation:</u></i> <i>Owner request to remove existing steps and install aluminum benches/ bleachers (3-4 tiers). This may trigger overall deck replacement and a substantial alteration designation for permitting; this item to be coordinated with structural and Owner.</i></p>

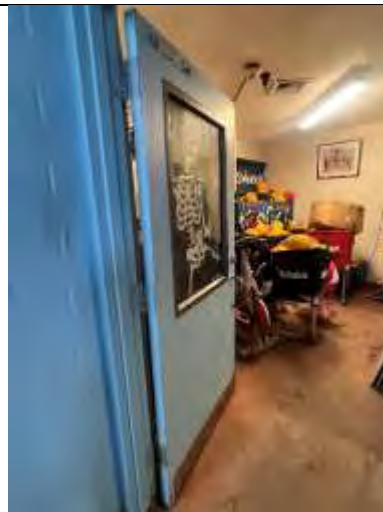
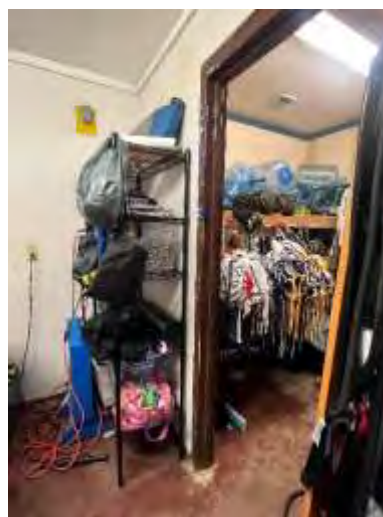
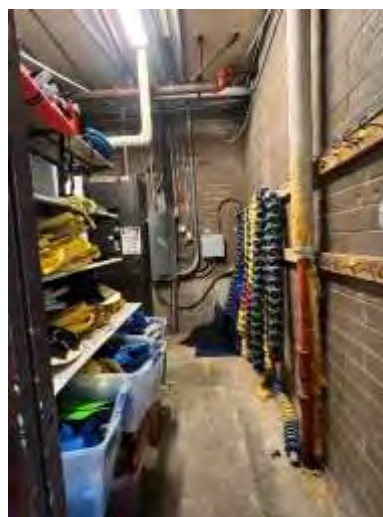
19. Deck level team storage on southwest.

Deficiency: Pool equipment that is for public or team use is stored in several rooms and are not ADA compliant. Lighting is aged and appears to be old T8/T5 fluorescents. Leak behind the main door.

Reconfigure/repurpose equipment storage spaces.

Update lighting to LED fixtures, door hardware, etc. to be accessible.

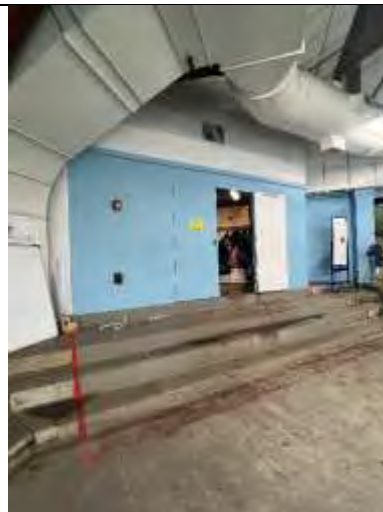
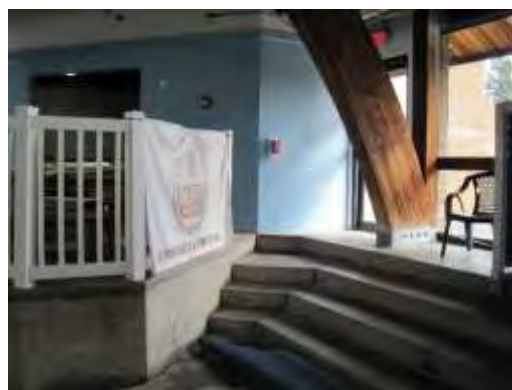
20. Public storage room at northwest and northeast
Deficiency: Public storage is not ADA accessible. Ceiling is in poor shape – moisture intrusion visible.
Recommendation: replace damaged wood members. Make this a staff use/storage area only.

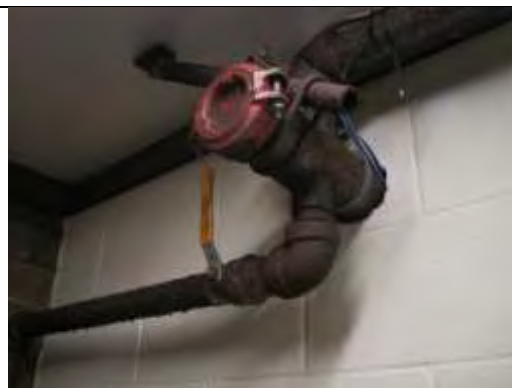
21. Natatorium/ Locker rooms/ storage rooms sprinkler heads and other plumbing pipes
Deficiency: existing sprinkler and plumbing pipes are extremely corroded.
Recommendation: clean all corroded pipes and coat with anti-corrosive coating. Refer to mechanical for this item.

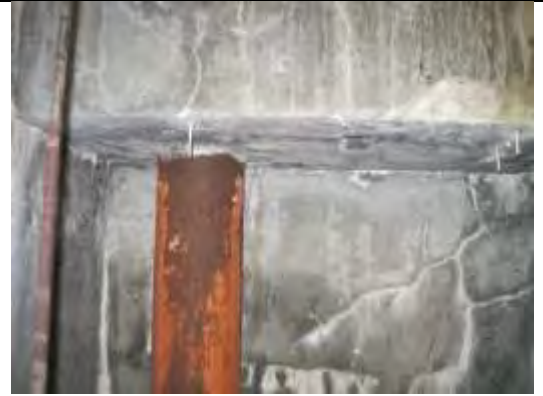
Deficiency: constant corrosive pool environment and chemical treatments over time has caused the concrete surfacing to effloresce.

Recommendation: Concrete shall be cleaned, spalled and delaminated concrete repaired, and sealed with epoxy or urethane cracked injection. Refer to structural report for repairs to concrete.

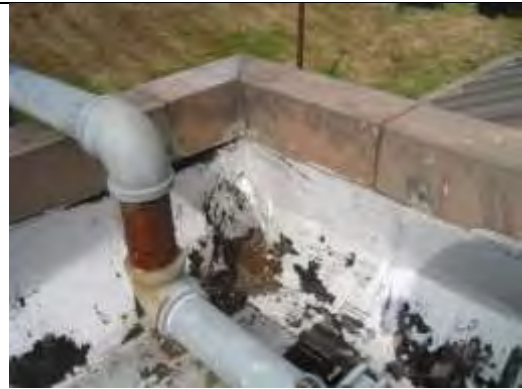
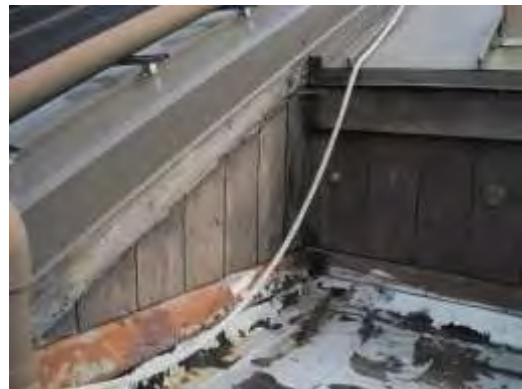
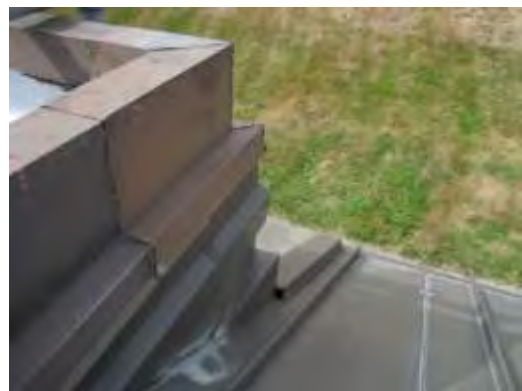
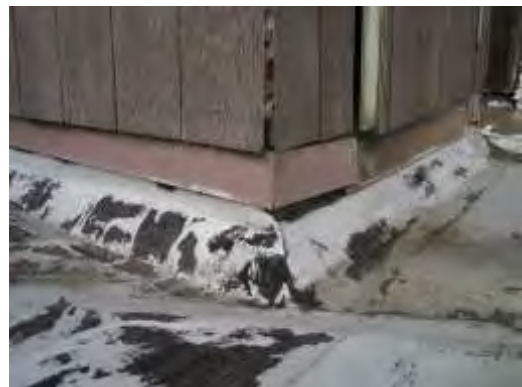
Deficiency: existing sheet metal flashing, counterflashing, and coping is corroded, aged, and failing at low slope roof area. This also includes the gutters.

Recommendation: replace sheet metal coping and flashing and gutter system.

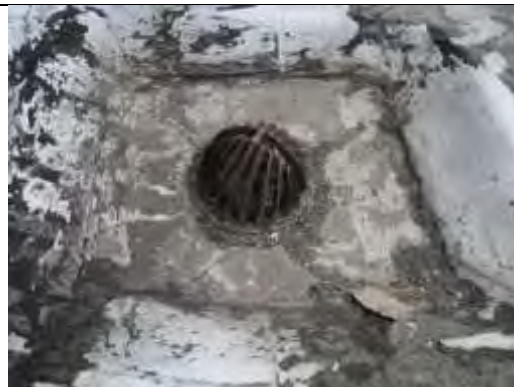
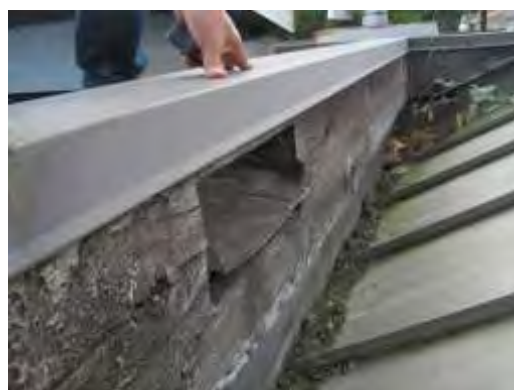
Deficiency: existing roof drains are aged and corroded.

Recommendation: replace roof drains and scuppers; verify condition of leaders for blockage, flow, and damage. Coordination with mechanical engineer required.

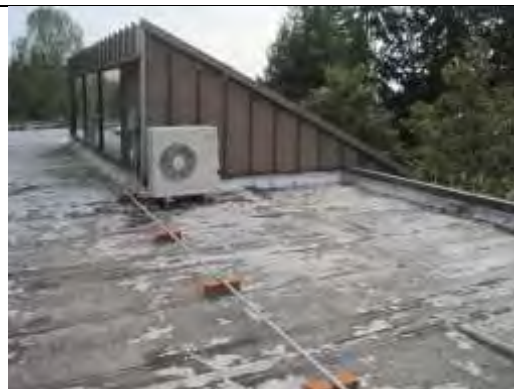
33. Fall protection – low slope roof

Deficiency: there is no fall protection on the existing roof.

Recommendation: Install fall protection. Coordinate with structural engineer.

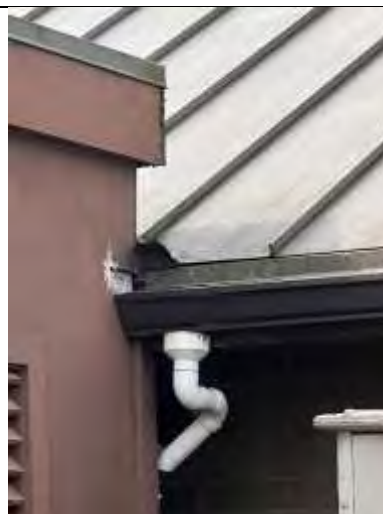
34. Gutters and downspouts

Deficiency: existing gutters and downspouts on the east side are leaking.

Recommendation: repair gutter to downspout connection on east side of building to prevent overflow.

General gutter system may need replacement.

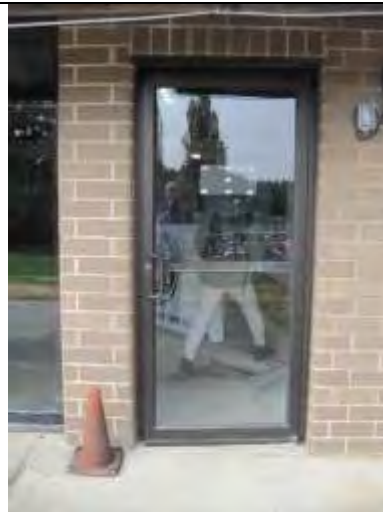
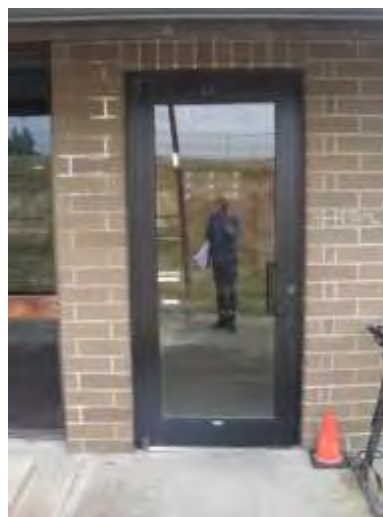
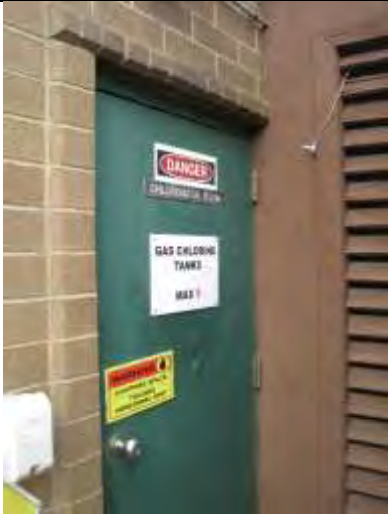
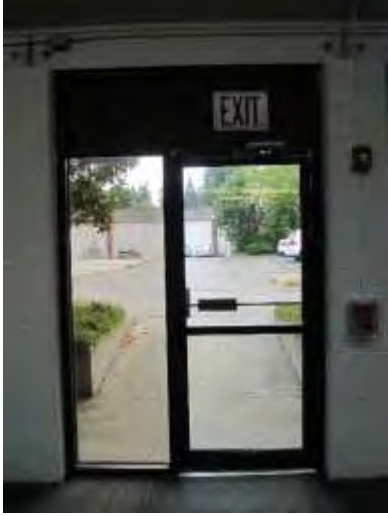
Deficiency: exterior doors at natatorium and auxiliary spaces (such as chemical room and workshop space) are aged; hardware and frame are corroded, seals are failing.

Recommendation: Replace exterior doors and hardware.

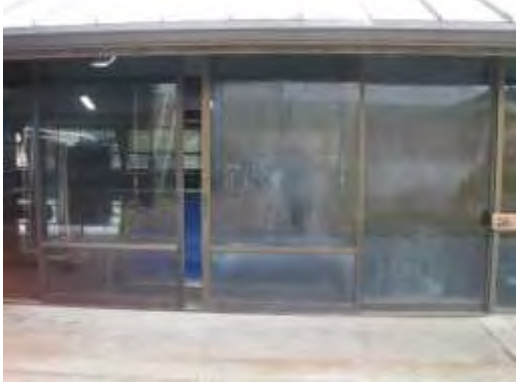
<p>36. Exterior sliding doors – east and west <i>Deficiency:</i> exterior sliding doors are aged and failing – seals are compromised and condensation and calcification have occurred at interior air space between the glass. <i>Recommendation:</i> Replace sliding glass doors – existing system is Kawneer; StemperAC is reviewing available compatible replacement sliding glass doors.</p>

Both storefront systems were manufactured by Kawneer, and are showing failed glazing units with broken seals and layers of condensation stains in between the inner and outer glass layers. The existing aluminum framing is in fair to poor condition and are showing oxidation and peeling/chipping of the dark bronze finish. The swinging doors are also aged and not all doors latch or close properly. Due to the age of the existing system, it is not advised that selective failed glazing units be replaced as the aluminum frame may not support or be compatible with new glazing units and would likely not comply with current energy code requirements. Therefore, it is recommended that the storefront windows and doors be replaced in their entirety with a new similar system (eg: curtain wall system), up-to-date, energy efficient glazing system.

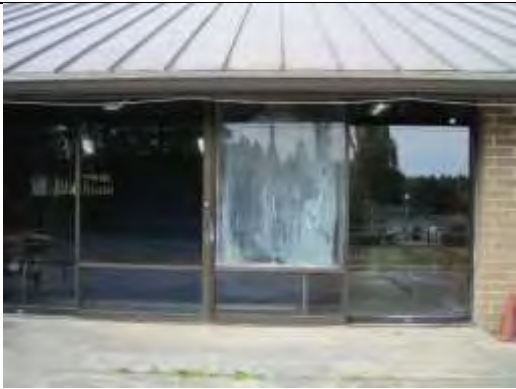
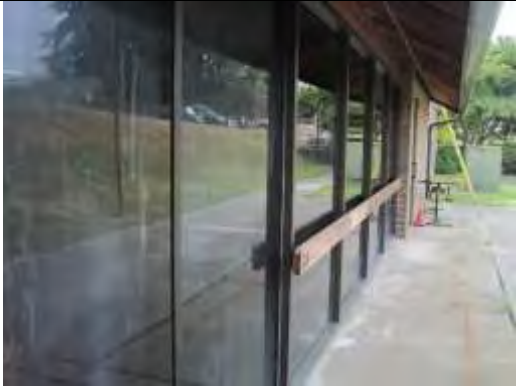
<p>37. Storefront windows – east and west</p> <p><i>Deficiency:</i> existing windows are aged, seals are failing, and some frames are corroded.</p> <p><i>Recommendation:</i> Replace storefront window system in its entirety; as with the sliding glass doors which are part of the same storefront system, StemperAC is reviewing options for a compatible system to replace this one.</p>

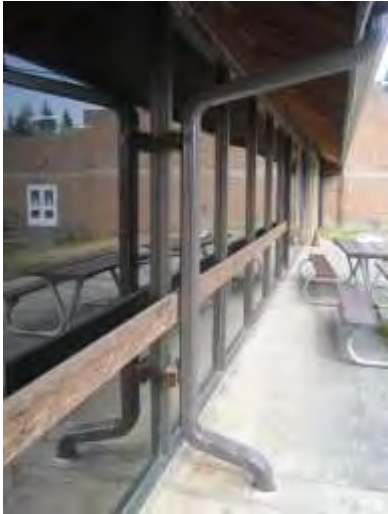
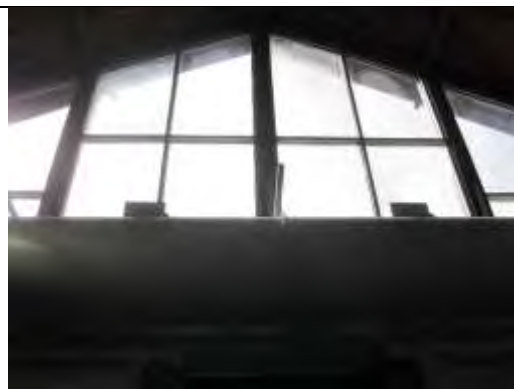
38. Clerestories – south low slope roof

Deficiency: clerestories are aged; seals appear to be failing and moisture leaking into office space below. They are also inoperable and does not allow for ventilation in the natatorium space during warm summer months

4. Clerestory Windows: the clerestory windows located on the south face of the natatorium appear to be part of the original 1977 construction to enclose the pool. The windows are not thermally broken, and do not appear to operate and/or allow for any ventilation in the pool area during warm summer months. Additionally, the seals are failing and this may be the source of moisture intrusion in to the ceiling space below as well as in to the roof membrane system. Replacement of the existing windows with motorized, thermally broken, operable windows will allow for the pool space to be ventilated and be compliant with energy codes. If this is cost prohibitive, an alternate option is to install a polycarbonate or fiberglass panel infill system which allows diffused light in the space but significantly blocks solar heat gain in to the space. Some of the panels could also be louvers to help ventilate during warm months. BI Parks mentioned that the existing clerestory windows can cause a glare problem in certain months/days as it is clear glass, and a diffused panel may work as a positive solution to prevent both glare and provide energy efficiency to the natatorium.

Recommendation: Replace clerestories in their entirety--install new remote controlled operable window units (to confirm with Owner on whether 'fixed' windows are preferred) which are energy code compliant; consider alternate solution: install window treatments in lieu of glass with a polycarbonate or fiberglass panel system which allows diffused light in to the space and provides energy efficient performance.

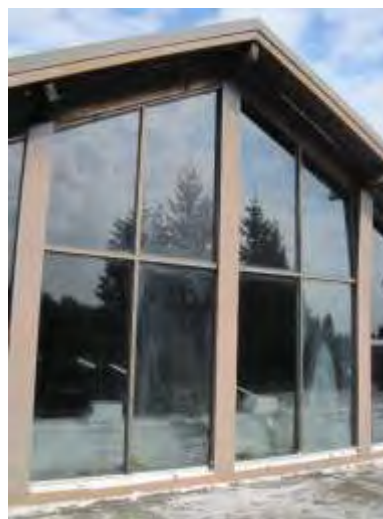
39. Transom – above south entrance

Deficiency: transom above south entrance door is missing.

Recommendation: Replace the entire storefront door system. Coordinate relocation/replacement of "Exit" sign –to comply with current code requirements with electrical engineer.

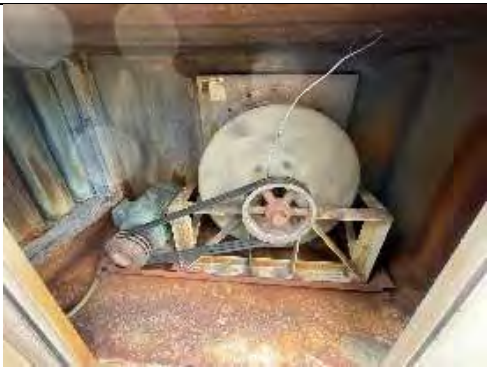
Description	Photo
<p>1. Pool area Heating/Ventilation system. (Critical - Life safety and energy code) <u>Deficiency:</u> M001 <u>Recommendation:</u> Remove and replace existing, failing, ground mounted air-to-air heat exchanger unit.</p>

1. Pool HV system: The existing Heat Reclaim Heating/Ventilation unit was installed in 1998. The design does not comply with the current Washington State Energy Code. The existing HV Unit is badly deteriorated from exhaust side chlorinated air. Panels and access doors are badly rusted and control dampers are inoperable. The system requires replacement. A more complex, code compliant unit with dehumidification will need to be installed. The dehumidification system will require additional electrical power, which will necessarily require a building electrical service upgrade. The existing air-to-air heat exchanger uses 100% outside air with heat exchanger bypass dampers for mild temperature operation. Supply air is currently re-heated with a draw through hydronic coil, downstream of the heat exchanger. The hydronic loop serving the existing unit shall be re-used with the new dehumidification equipment. The distribution ductwork and aluminum diffusers within the pool room are in good shape and can be re-used. The existing exterior supply and exhaust ductwork is deteriorated and will require replacement and reconfiguration. The interior exhaust louver in the west wall of the pool enclosure is an aluminum sound attenuation louver. The louver is in good shape and can be re-used. The existing supply and exhaust fans are modulated by exterior ABB Variable Frequency Drives (VFD's), These VFD's are controlled by a Johnson Metasys DDC system but it is not known if the VFD's are fully functional. New fan motor modulation will be required. The old VFD's will be replaced by more modern ECM motor controls installed in the new equipment. The DDC system needs to be upgraded to accommodate the newer, more complex equipment. A new, larger concrete equipment pad will be required. The fenced equipment enclosure may require expansion. The enclosure will require removal of debris and blackberry overgrowth.

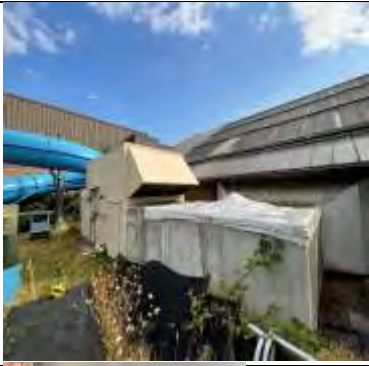
<p>2. Locker Room Heating, Ventilation systems.(Critical - Life safety and energy code) <u>Deficiency:</u> M002 <u>Recommendation:</u> Remove and replace existing, failed, abandoned heating ventilation equipment installed in the roof penthouses and replace all existing distribution ductwork.</p>

2. Locker room HVAC: The two (2) roof mechanical rooms have conventional McQuay air handling units, exhaust fans and heat tube type air-to-air heat exchangers. The two (2) systems are badly corroded and were turned off when the locker rooms were abandoned. The units are old and are assumed to be inoperable. Locker rooms in the adjacent Nikata pool building now serve the entire facility. The existing pool locker rooms are to be demolished and the spaces re-configured for alternative uses. We suggest the re-configured spaces be heated and ventilated with conventional HVAC systems installed in the same mechanical rooms. The new systems should provide pressurization so as not to allow infiltration of the corrosive pool air into the spaces. The new units will be designed based on the needs of the re-configured spaces. The DDC will need to be expanded to support these systems.

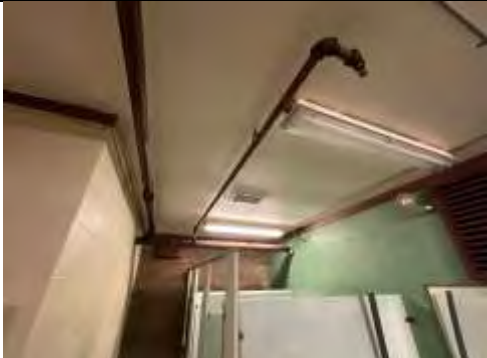
<p>4. Existing rusted Waste and Vent piping. (Secondary-wear and tear) <u>Deficiency:</u> M004 <u>Recommendation:</u> Existing waste and vent piping is badly rusted from Chlorine fumes. Replace all waste and vent piping with PVC piping.</p>

4. Waste and Vent Piping: All waste and vent piping is badly rusted and is in need of re-placement with PVC piping. With the reconfiguration of the locker rooms to alternative uses and the removal of the old locker room plumbing fixtures, much of this rusty piping can be simply demolished and underground, non-accessible piping can be abandoned in place. New plumbing fixtures shall be provided with plastic, PVC waste and vent piping.

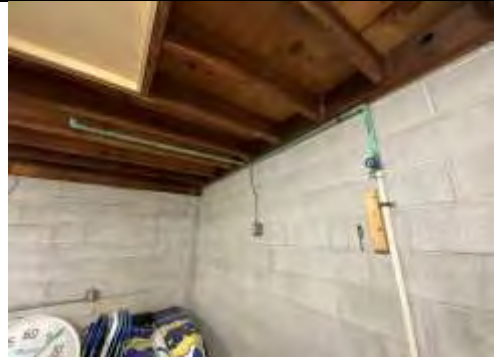
<p>5. Domestic Water Piping (Secondary - wear and tear) <i>Deficiency: M005</i> <i>Recommendation:</i> Chlorine fumes have deteriorated the domestic water piping. Replace all domestic water piping with plastic pipe.</p>

5. Domestic Water Piping: Much of the original water piping was galvanized steel, which has leaked and been patched and partially replaced with various piping materials. All water piping needs to be replaced with plastic piping systems either PEX if concealed or PVC/CPVC if exposed.

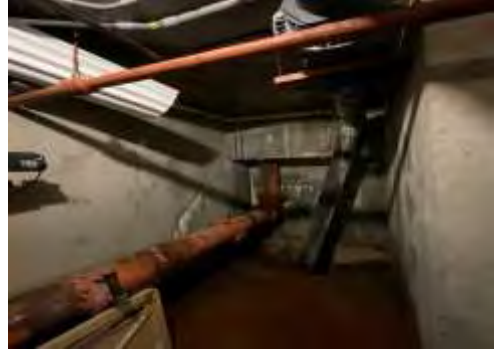
<p>6. Pool drainage piping (Secondary -Wear and tear) <i>Deficiency: M006</i> <i>Recommendation:</i> The pool drain piping is the original steel materials and is suspected of leaking. Line all existing pool drain piping with a plastic liner system.</p>

6. Pool and deck drainage piping: Pool drain piping has been previously identified as leaking. We suggest all pool drain piping be retrofitted with a plastic pipe-lining system.

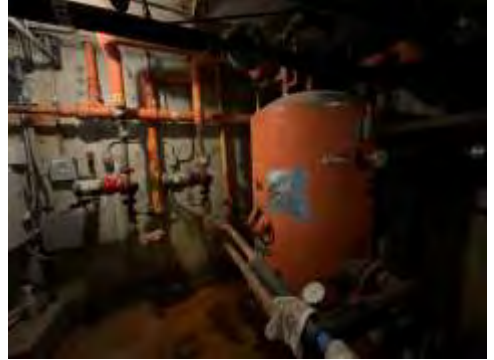
<p>7. Domestic water heater (Secondary -wear and tear) <i>Deficiency: M007</i> <i>Recommendation:</i> The domestic water system has failed and is abandoned in place. Install a new domestic Point of use water heaters with new area re-configuration.</p>

7. Domestic Water Heater: The existing water heating system consists of an insulated tank with a water heating tube bundle connected to the pool heating boiler. The water heating system has been abandoned in place due to age and corrosion; There is now no hot water available in the pool buildings. The existing tank is insulated with asbestos insulation, which will require abatement. When the locker room areas are re-configured to other uses, there will be much less demand for domestic hot water. We suggest a new, smaller water heating system be installed to accommodate the area re-configuration. Point-of-use electric water heaters are indicated, but the new domestic hot water system shall be designed to meet the needs of the new re-configured areas.

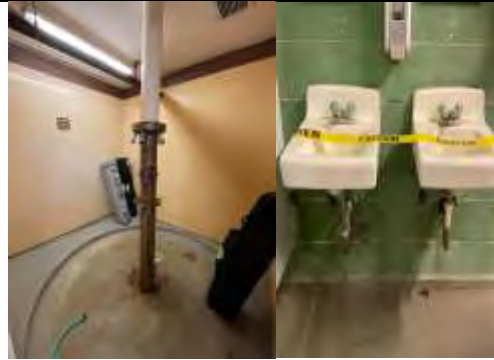
<p>8. Plumbing fixtures (Secondary -Wear and tear) <i>Deficiency: M008</i> <i>Recommendation:</i> Demolish all plumbing fixtures and install new fixtures required for reconfiguration of space.</p>

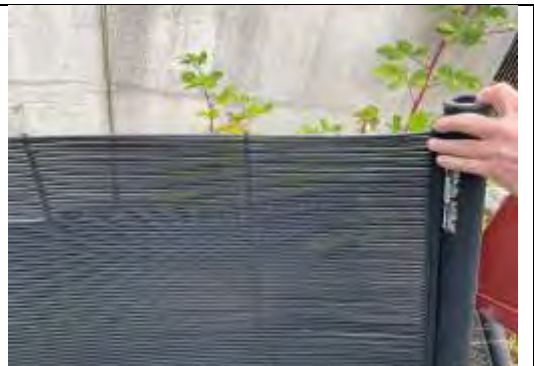
9. Solar Heating System: (Secondary -Wear and Tear)
Deficiency: M009
Recommendation: Paint remainder of exposed Roof mounted PVC piping and reconfigure pumps valving for redundant operation.

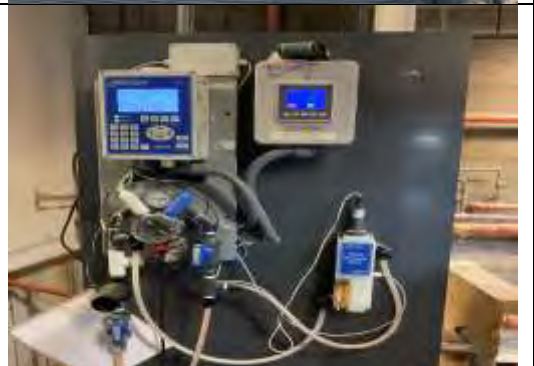
10. Chemical Treatment System (Secondary- Want list)
Deficiency :M010
Recommendation: Replace gaseous chemical maintenance system with salt/chlorine system.

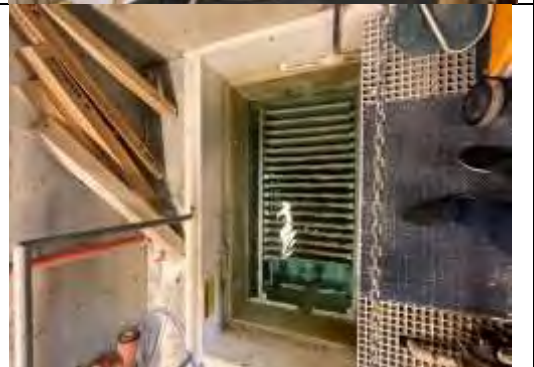
11. Pool Filtration System (Secondary – Want list)
Deficiency: M011
Recommendation: Replace existing open DE filter with backwash type sand filter.

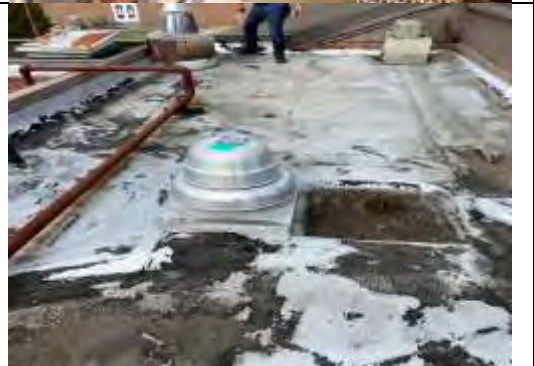
12. Roof Overflow Drains (Secondary – Code Requirement)
Deficiency: M012
Recommendation: Install overflow roof drains on locker room roof if roof is replaced.

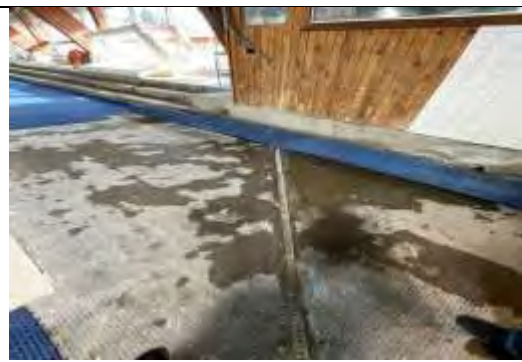
13. Pool Deck Drains (Secondary – system upgrade)

Deficiency: M013

Recommendation: If the pool deck is to be replaced, the deck trench drains should be replaced at that time.

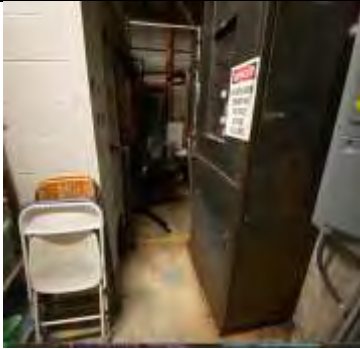
<i>Description</i>	<i>Photo</i>
<p>1. Main Distribution Panel (Critical – wear & tear, electrical code, support mechanical upgrades) <i>Deficiency: Panel is past its life expectancy and is in poor condition with corrosion. Does not meet code-required clearances.</i> <i>Recommendation: Replace panel with new. Provide code-required clearances. Upgrade electrical service to provide power required for the Pool HV System.</i></p>

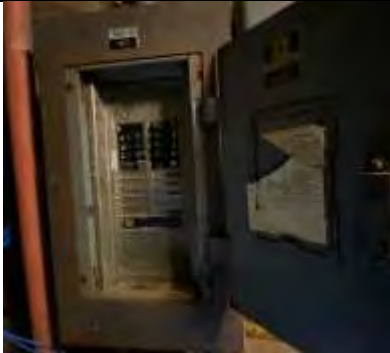
<p>2. Panel X (Secondary – wear & tear) <i>Deficiency: Panel is past its life expectancy and is in poor condition with corrosion.</i> <i>Recommendation: Replace panel with new.</i></p>

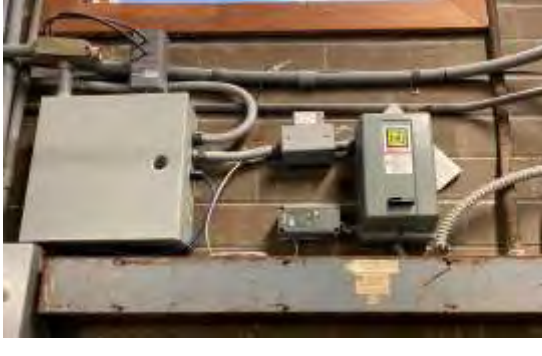
<p>4. Miscellaneous electrical raceways, auxiliary gutters, boxes, fittings, supports (Secondary – wear & tear) <i>Deficiency:</i> These items are in various states of corrosion. <i>Recommendation:</i> Replace with materials suitable for wet/natatorium locations.</p>

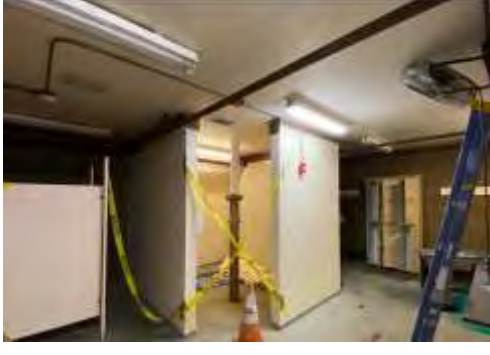
<p>5. Lighting (Secondary – energy efficiency) <i>Deficiency:</i> Lights in spaces other than the pool area utilize fluorescent lamps and are not as energy efficient. <i>Recommendation:</i> Replace all lighting with high-performance LED fixtures that are also properly rated for the environment they are in.</p>

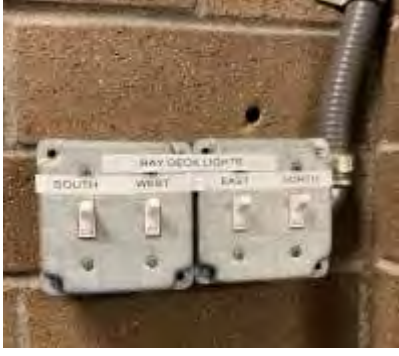
<p>6. Lighting Controls (Secondary – energy code and improved user experience with dimming) <i>Deficiency:</i> Lights in offices, lockers, and storage areas are controlled via line voltage switching with no occupancy sensor control. <i>Recommendation:</i> Replace with digital or wireless lighting control and provide occupancy sensors for automatic shutoff.</p>

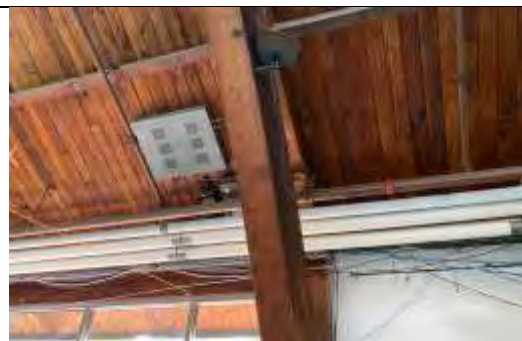
7. Communication Cabling Support (Secondary – low voltage cabling standards)

Deficiency: Low voltage communication cables are not installed in a neat and workmanlike manner, with some cables supported by extremely rusted piping.

Recommendation: Neatly bundle cabling and route in its own raceway or cable tray where exposed.
